The restoration of the Muhammad Ali Mosque in Cairo, 1931-1938

Mercedes Volait

Mercedes Volait. The restoration of the Muhammad Ali Mosque in Cairo, 1931-1938. Claudine Piaton; Ezio Godoli; David Peyceré. Building beyond the Mediterranean, studying the archives of European businesses (1860-1970) , Honoré Clair, p. 175-183, 2012. halshs-01312322

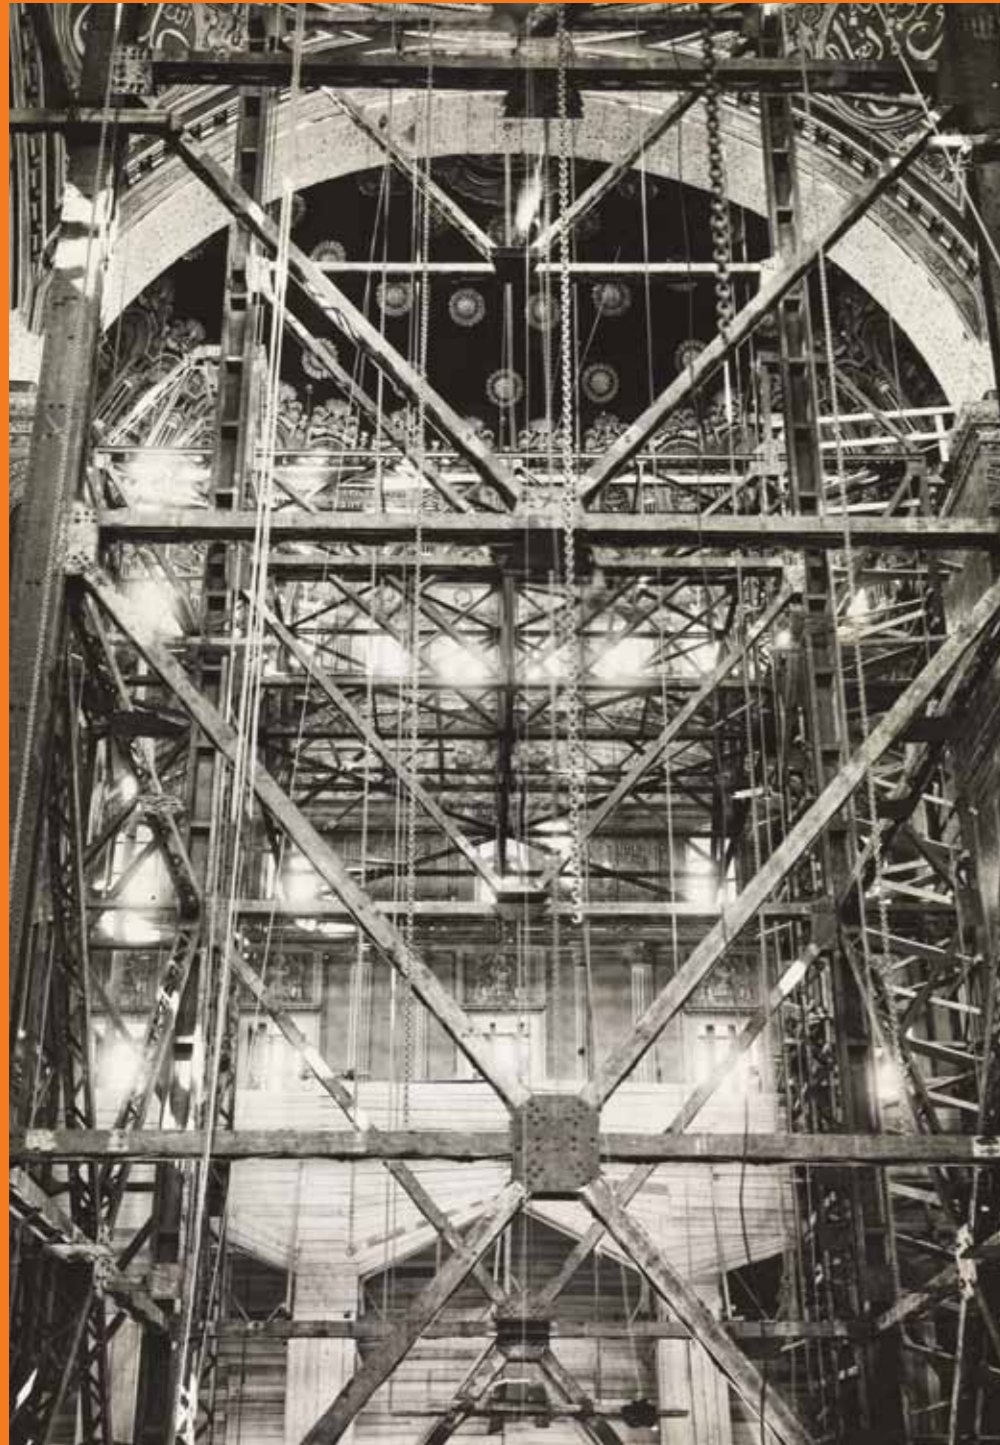
Muhammad Ali Mosque, Cairo: The interior scaffolding for restoration in the 1930s

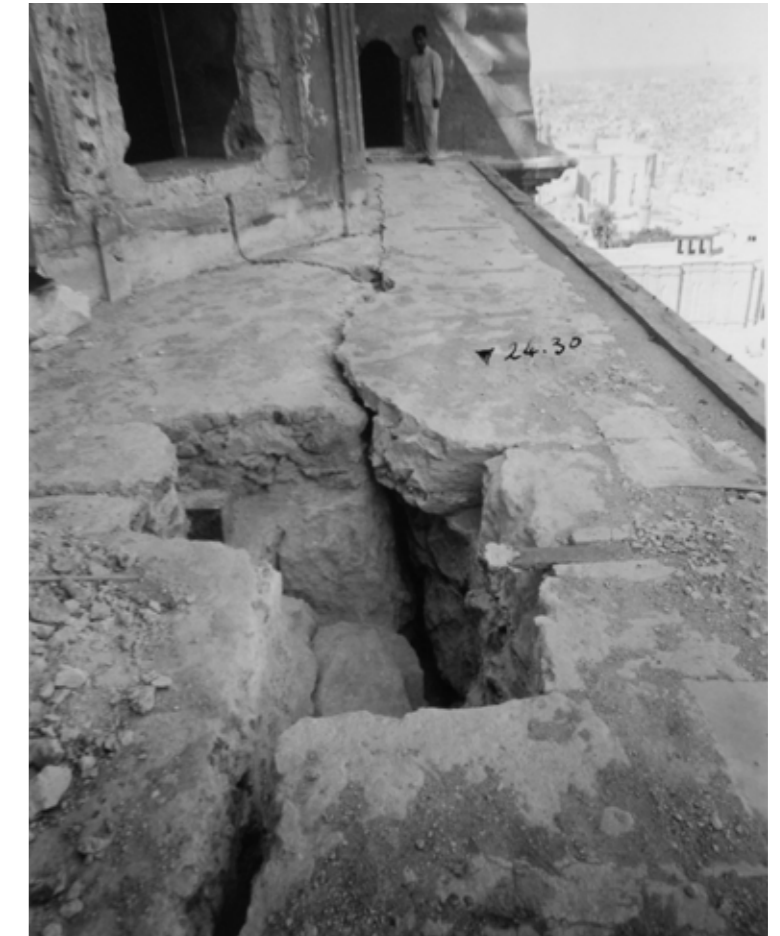
Muhammad Ali Mosque, Cairo: Cracks at the top of the northern wall

de Conservation des Monuments de l'Art Arabe, the protection agency for historic monuments created in 1881, so that its maintenance could be supervised.³⁷⁰ It was on this occasion that a detailed examination of the building took place, and revealed worrying deterioration. The mosque had cracks all over, some fissures appearing through the entire height of the building; others, located at the bases of pillars, were almost 10 cm wide. Urgent action was required.

of strain were made³⁷⁴ and indicators were put in place. Sixteen months later, in May 1933, examination cleared the foundations of responsibility for the deterioration. A chemical analysis by Ismail Omar showed that the cracks were caused not by the materials used for the domes (bricks and mortar), but by their support structure: arches, drums, pendentives, and pillars. A verticality check showed that the building was sagging towards the exterior; on the walls, the deformation equalled 10 cm for 11 m in height, while in the minarets, some 20 cm of deflection were measured. The calculation of average strain led to the conclusion that the building's structural mechanics suffered under the thrust from horizontal forces. By elimination, the Commission came to identify the structural reasons for the deformities and tearing as insufficient anchorage of the straps placed at the springing of the arches, as well as rust. The iron dowels, sealed in lead, binding the stones together, like the metal ring around the drum, revealed badly eroded areas. It also appeared that the building had been weakened by a past earthquake, the later explosion of a munitions store, and Cairo temperatures.³⁷⁵

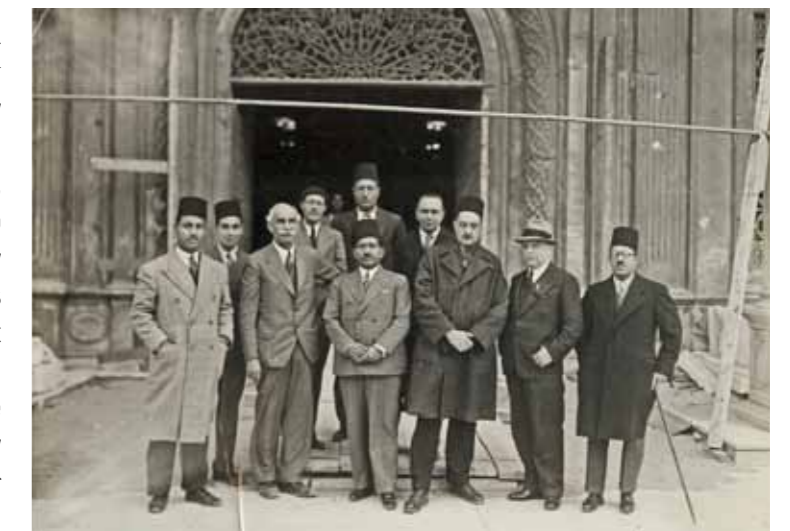
Muhammad Ali Mosque, Cairo: Demolition of the great dome, February 1935

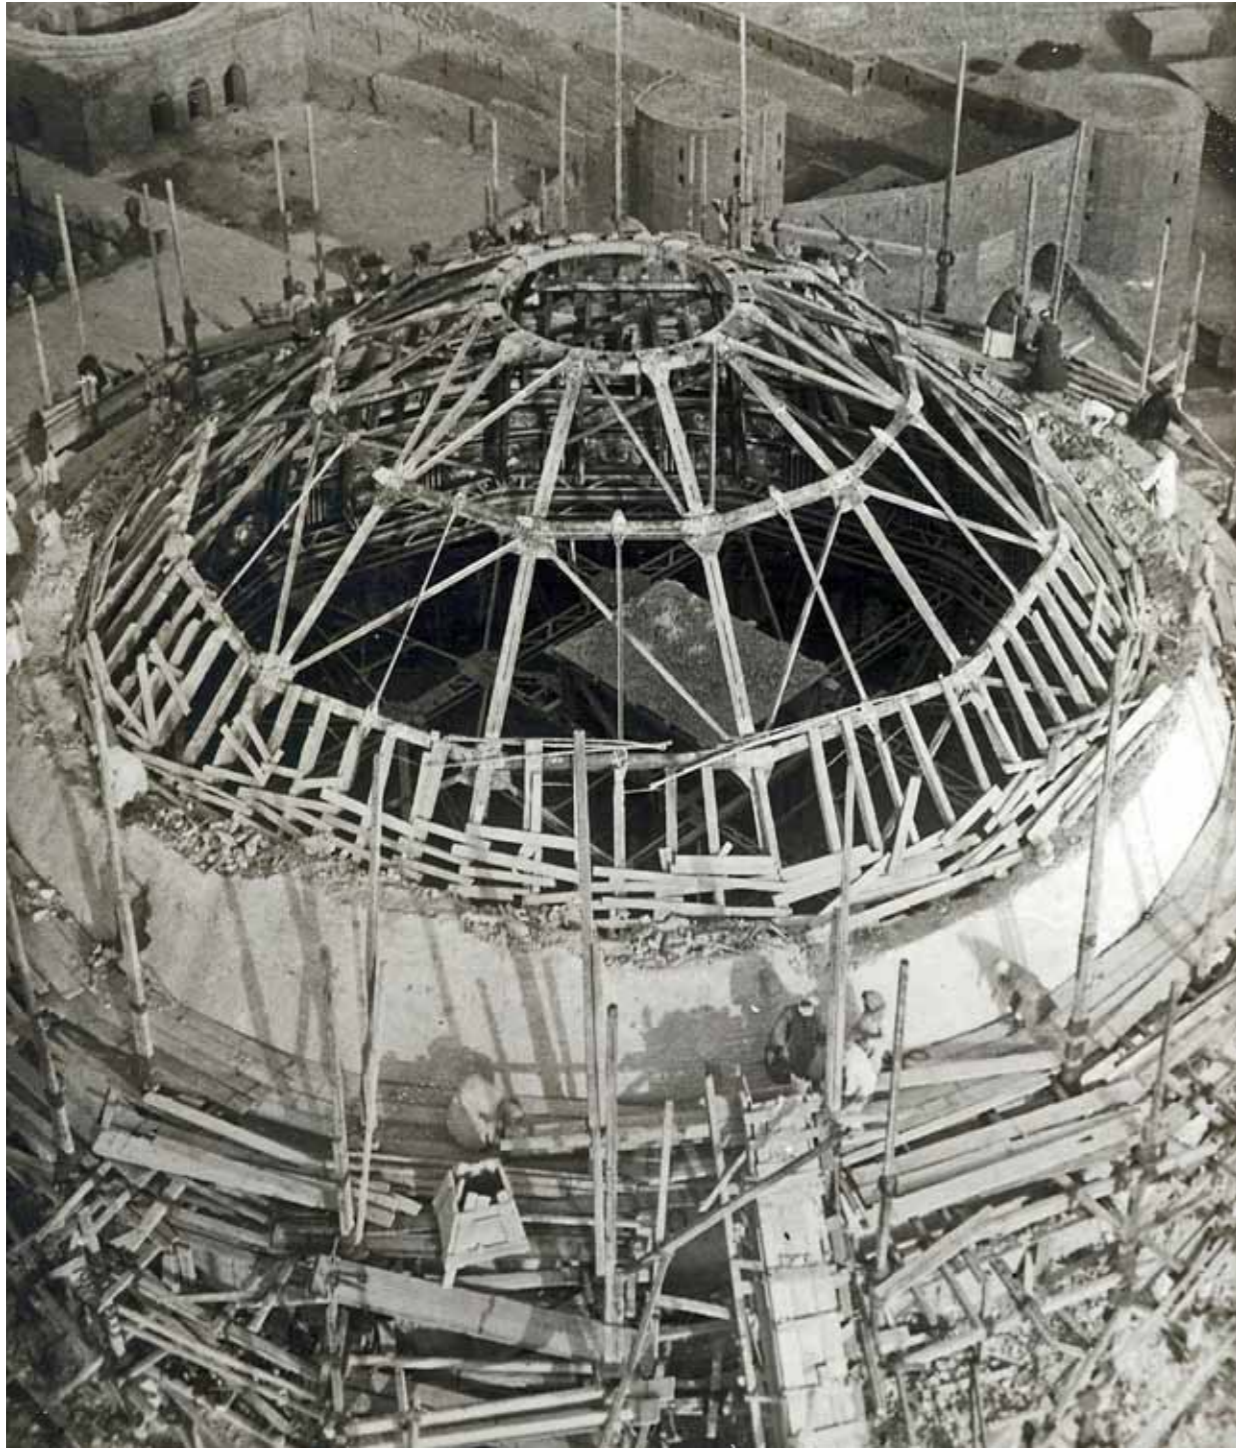
Muhammad Ali Mosque, Cairo: General view after dome demolition, July 1935

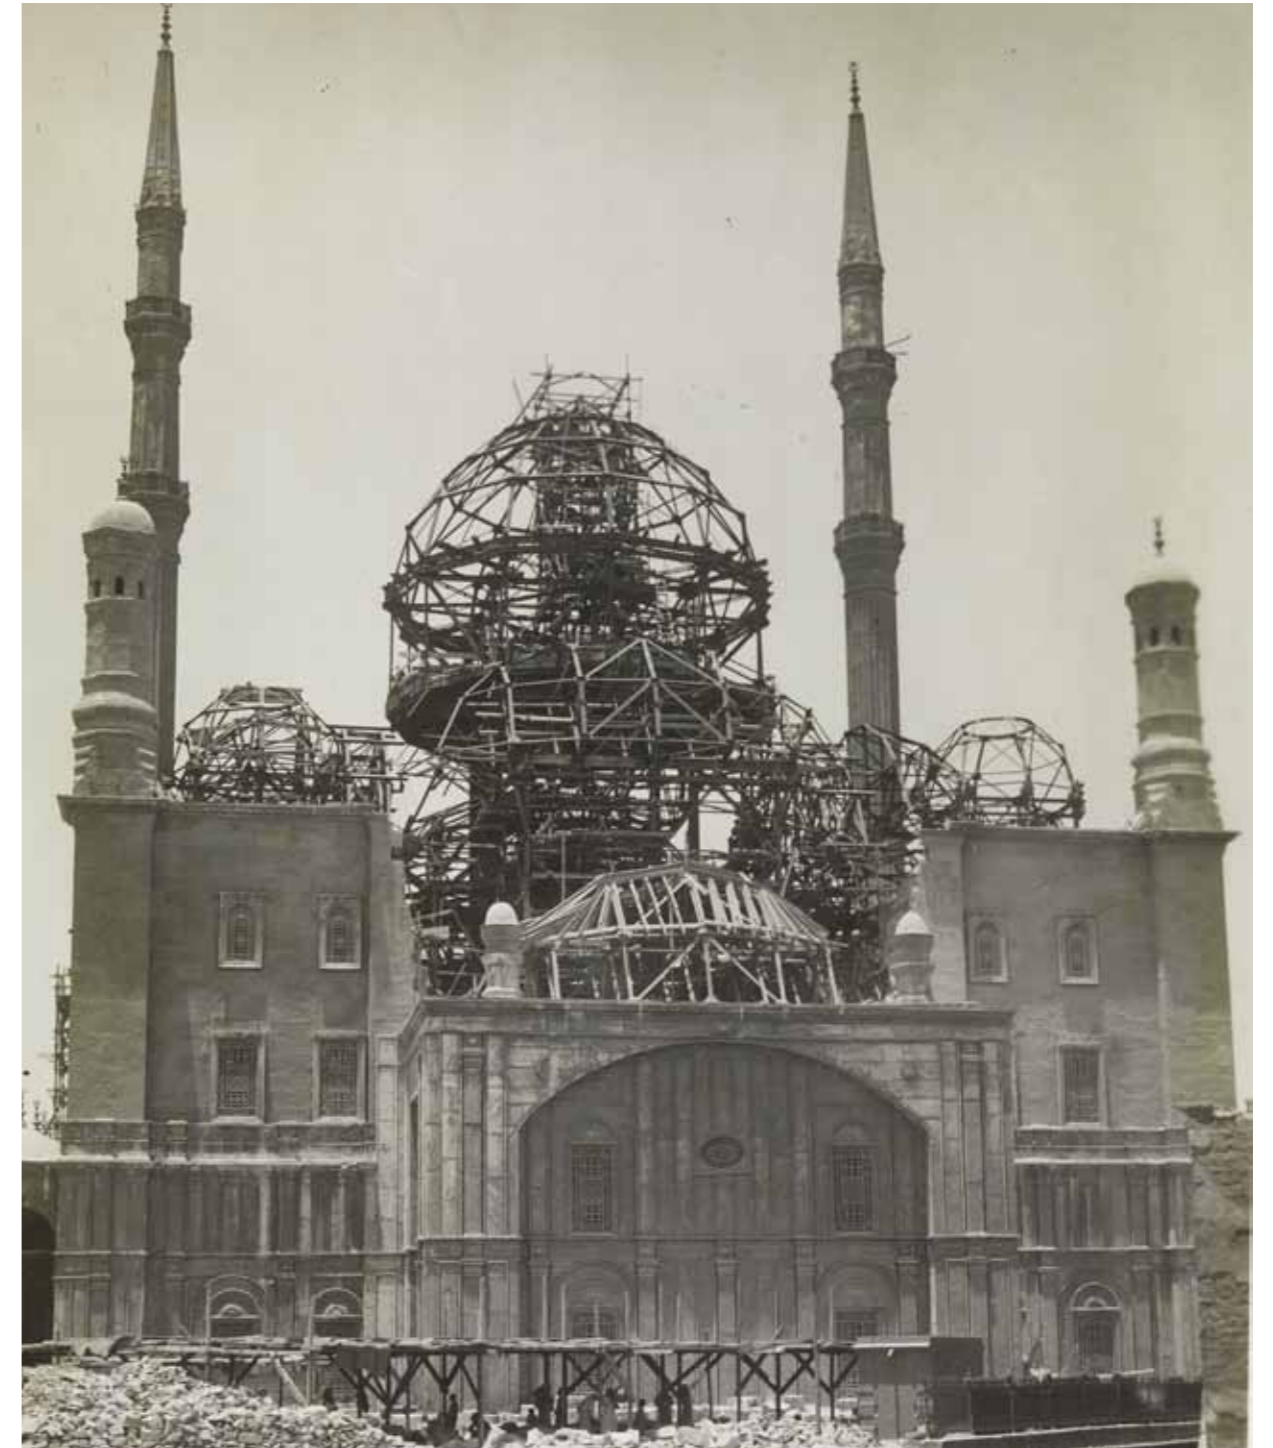
Muhammad Ali Mosque, Cairo: Installing the timber casing for the large reinforced concrete dome, autumn 1935

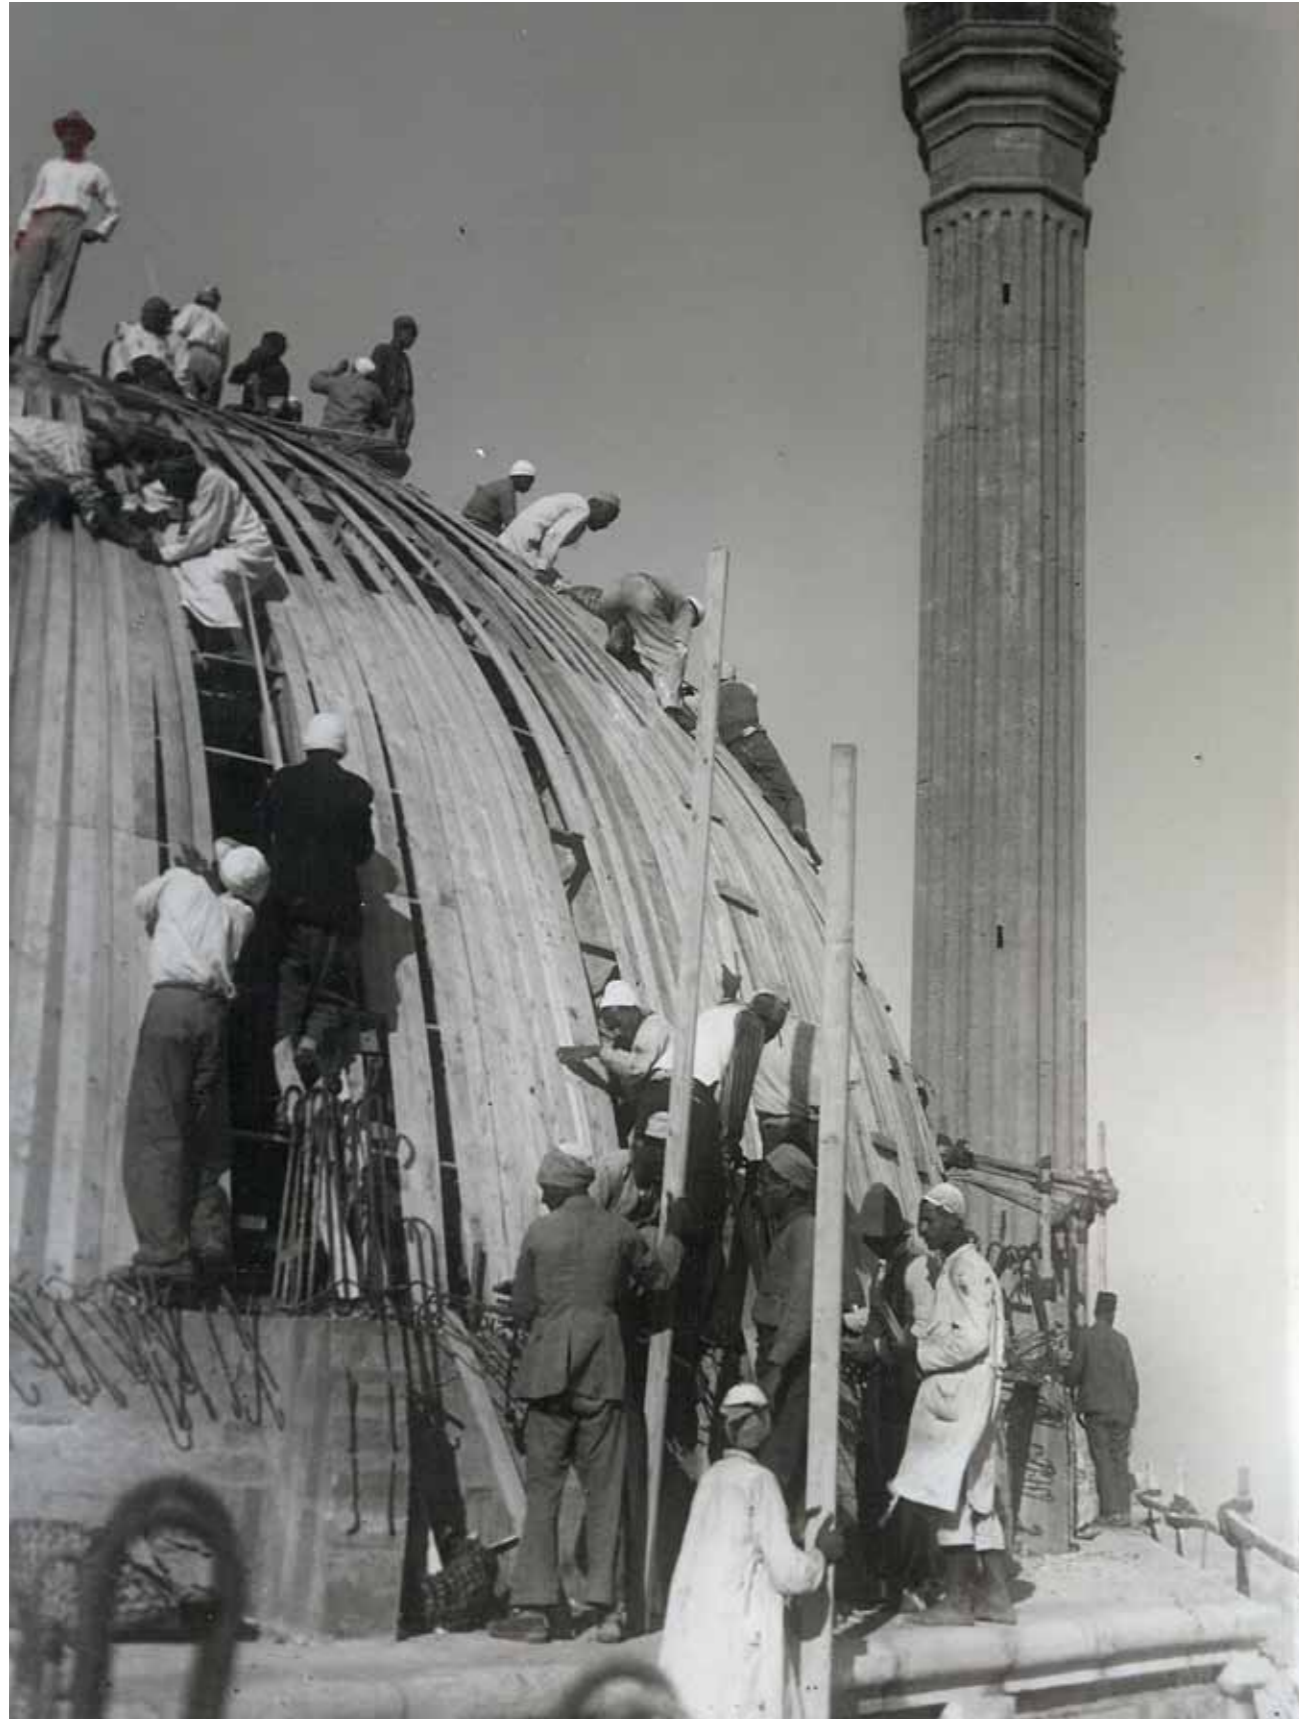
Installing the concrete tiles for the west half dome, January 1936

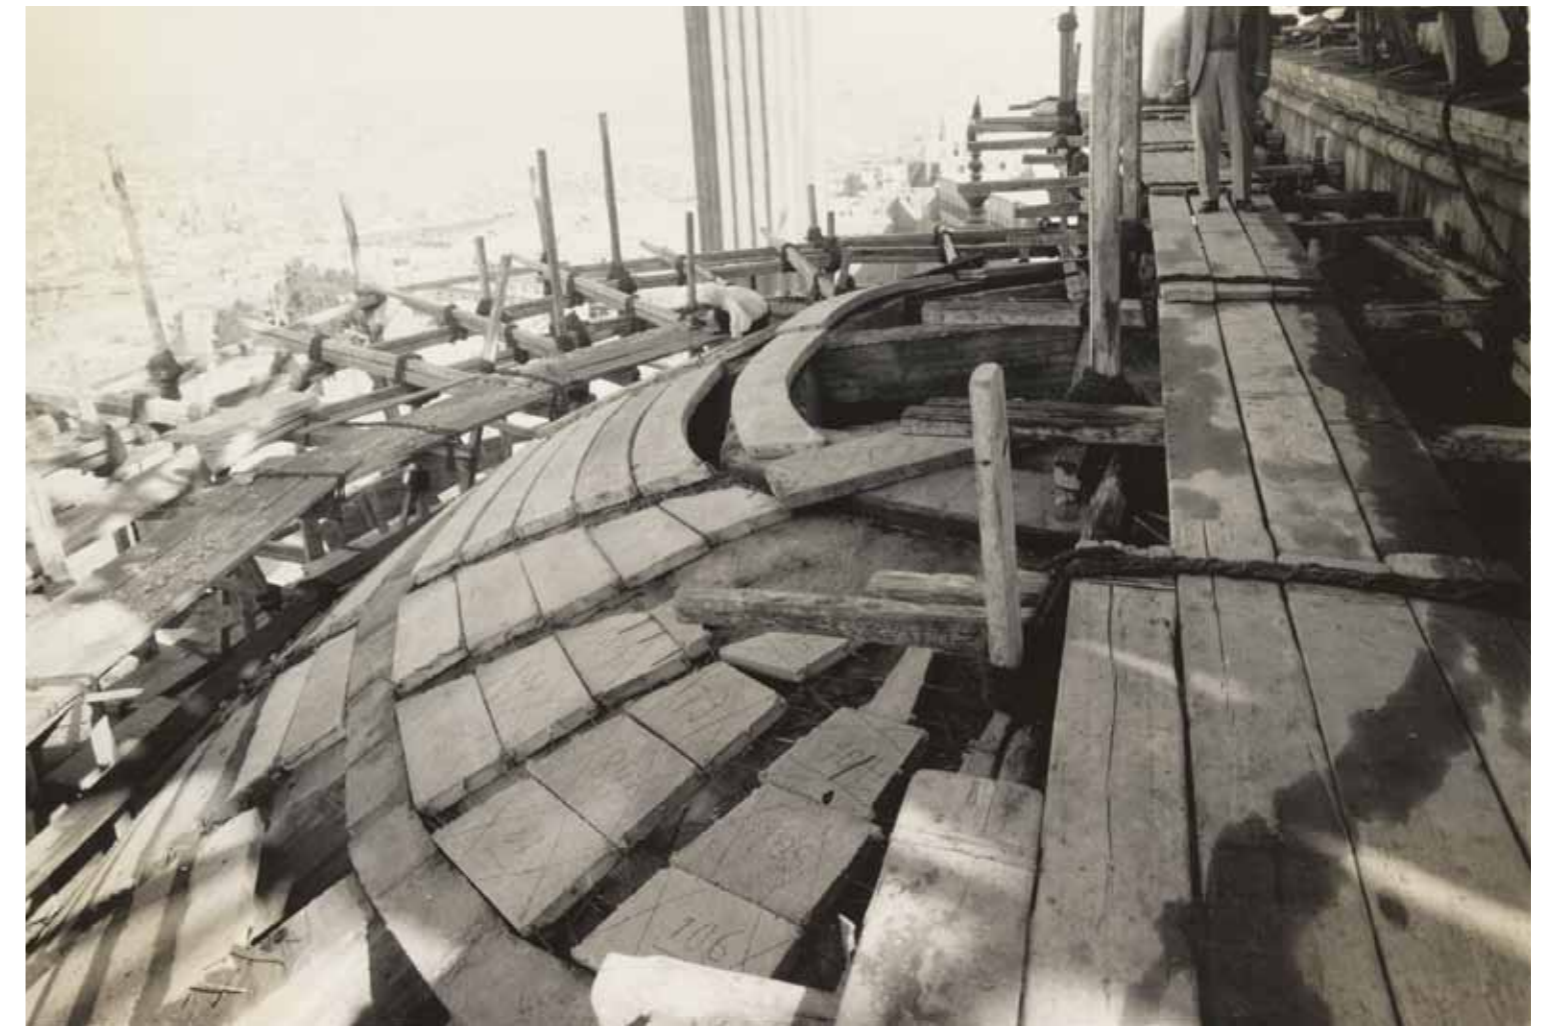
Muhammad Ali Mosque, Cairo:
Reinforcement of the concrete slab at the
base of the northern minaret, August 1934

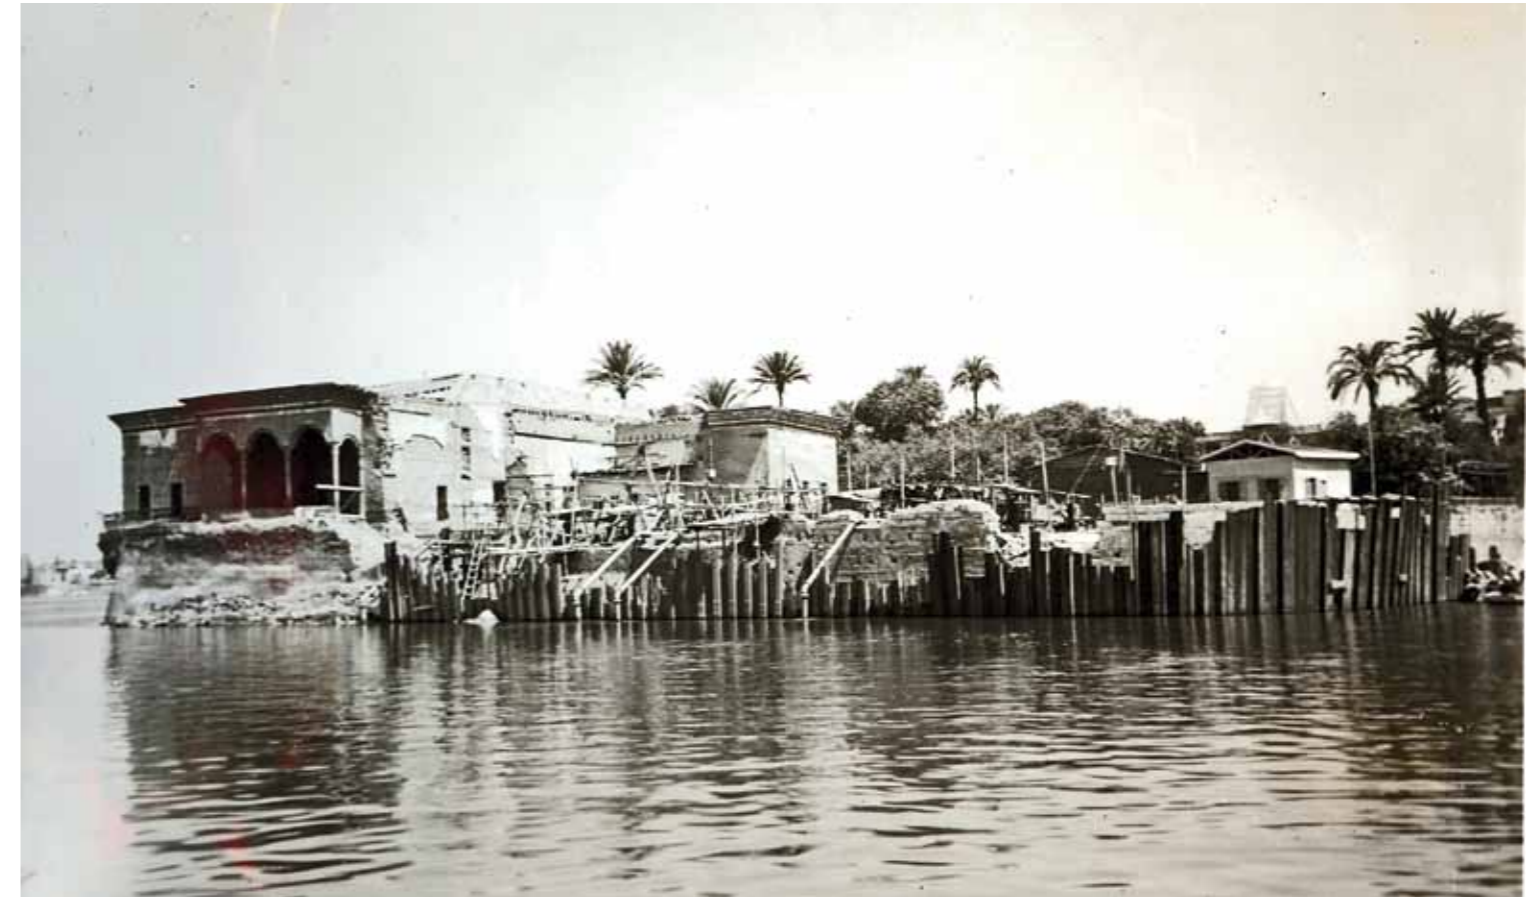
Roda Island Nilometer, Cairo:
Restoration work in progress (1937–1938)
