**Socio-cultural characteristics and policies vis-à-vis seismic risk reduction through post-quake rural reconstruction : a case study of Azad Jammu and Kashmir, Pakistan**

**THÈSE / UNIVERSITÉ DE BRETAGNE OCCIDENTALE**

**Socio-cultural characteristics and  
policies vis-à-vis seismic risk  
reduction through post-quake  
rural reconstruction :**  
*A case study of Azad Jammu and  
Kashmir, Pakistan*

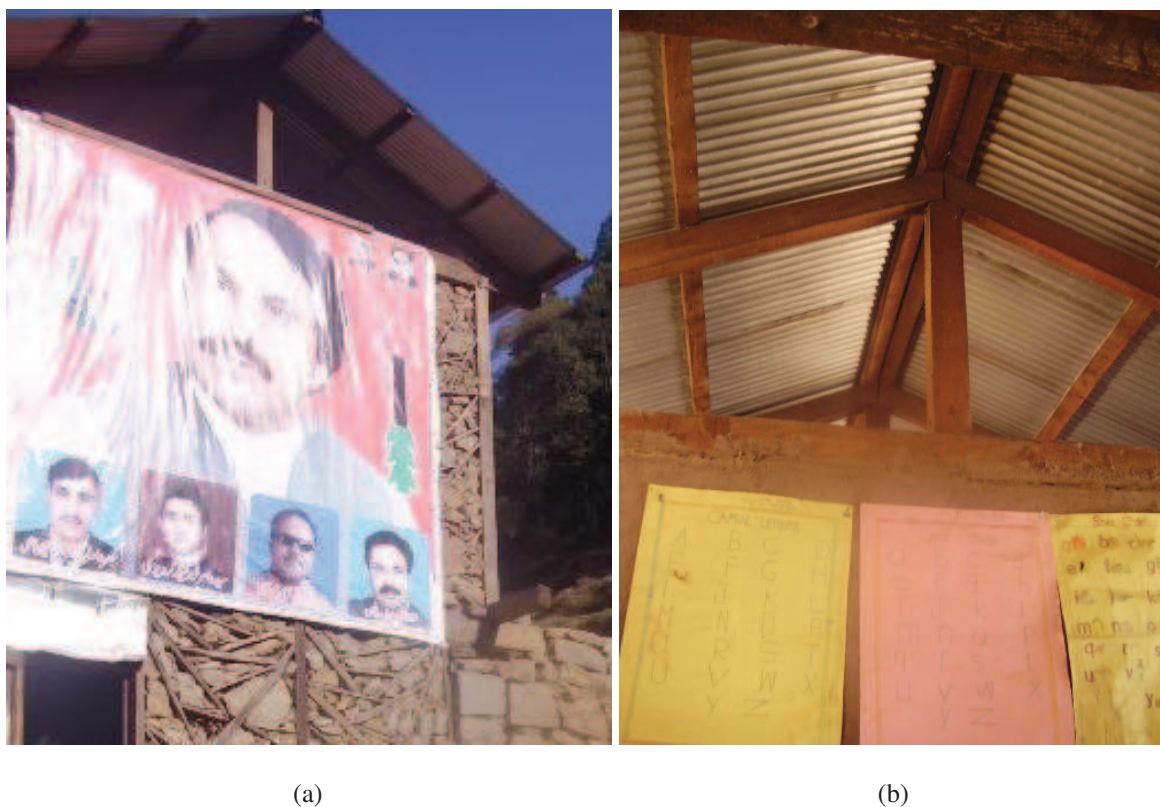
**Figure 5.22** — Outside and inside views of the roof. it is not only open to the outside ; also it decreases the inner temperature because of its height. Source : S. Abidi

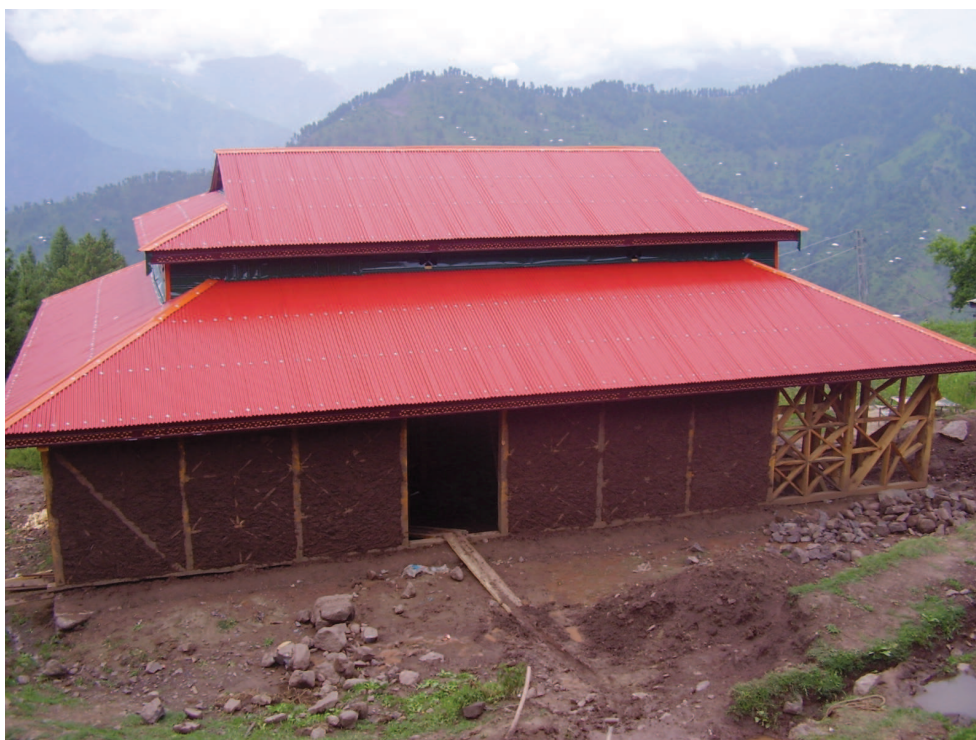
*Figure 6.1* — A type of tower roof. Source : S. Abidi

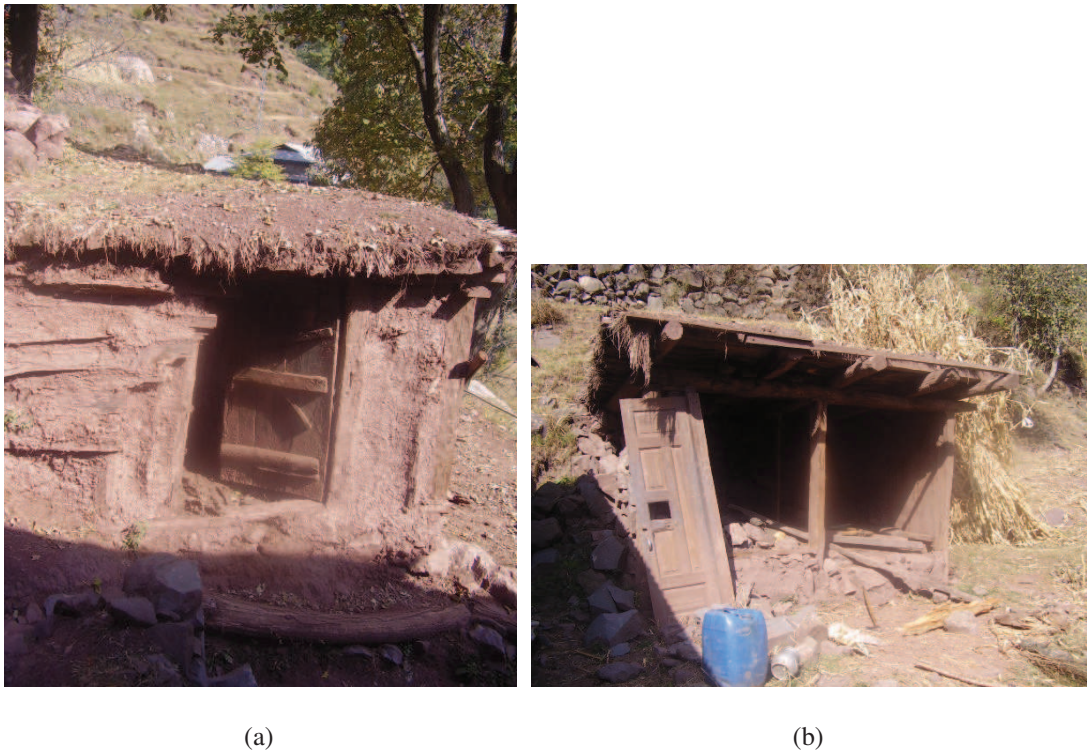
*Figure 6.5* — Flat roofs with thatch mixed mud mortar to cover the wooden frames (a) : Existing cattle shed) ; (b) Earthquake remains. Source : S. Abidi.

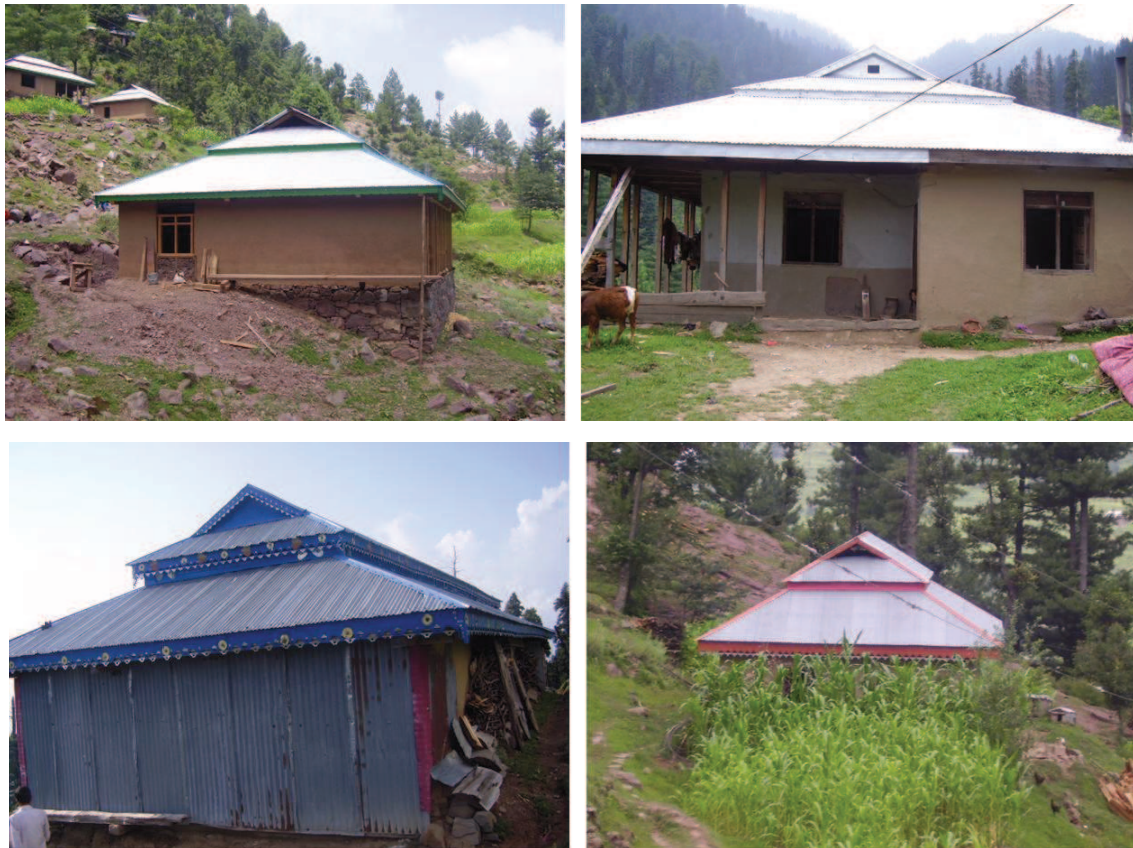
*Figure 6.31* — Negligible break dutch gable roof. Source : S. Abidi

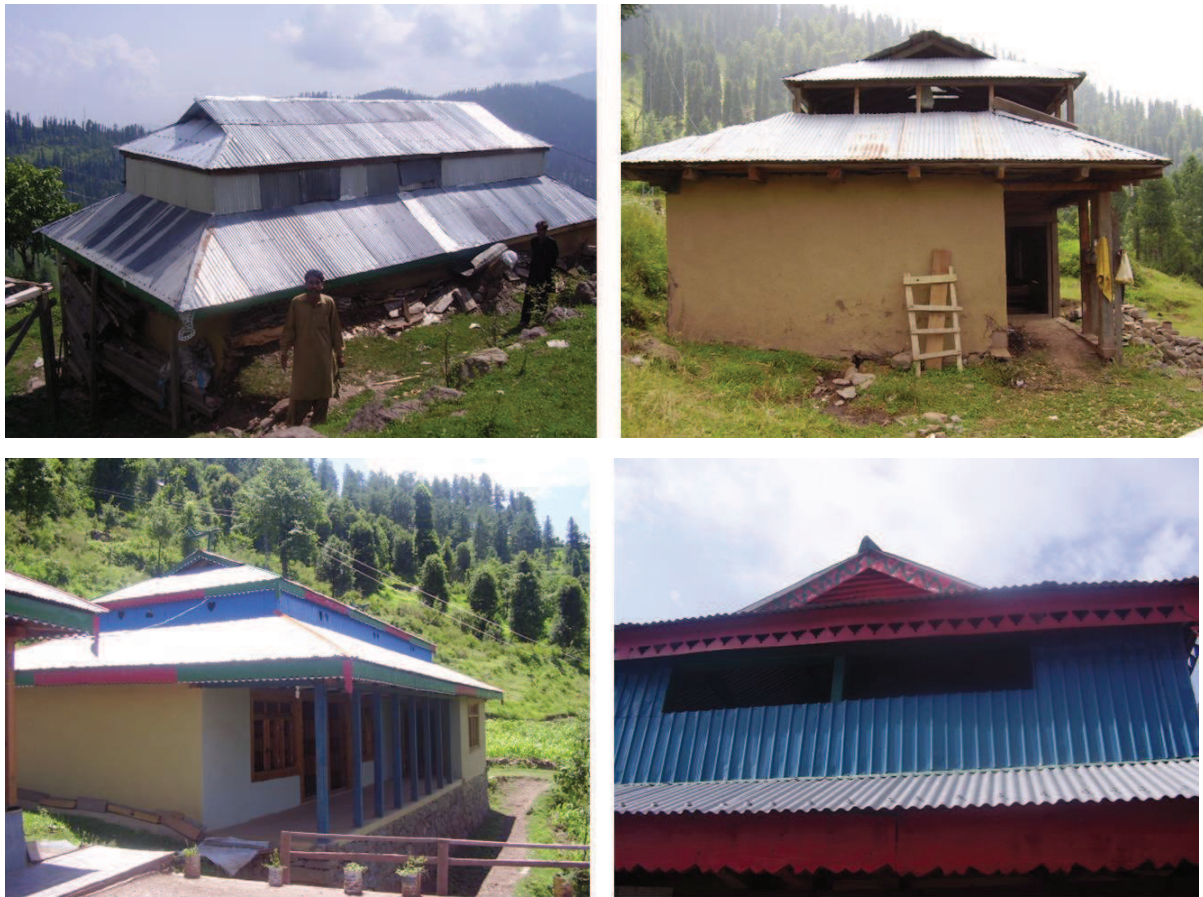
*Figure 6.35* — A prominent break in the roof, Dutch Gable roof can be observed Above.

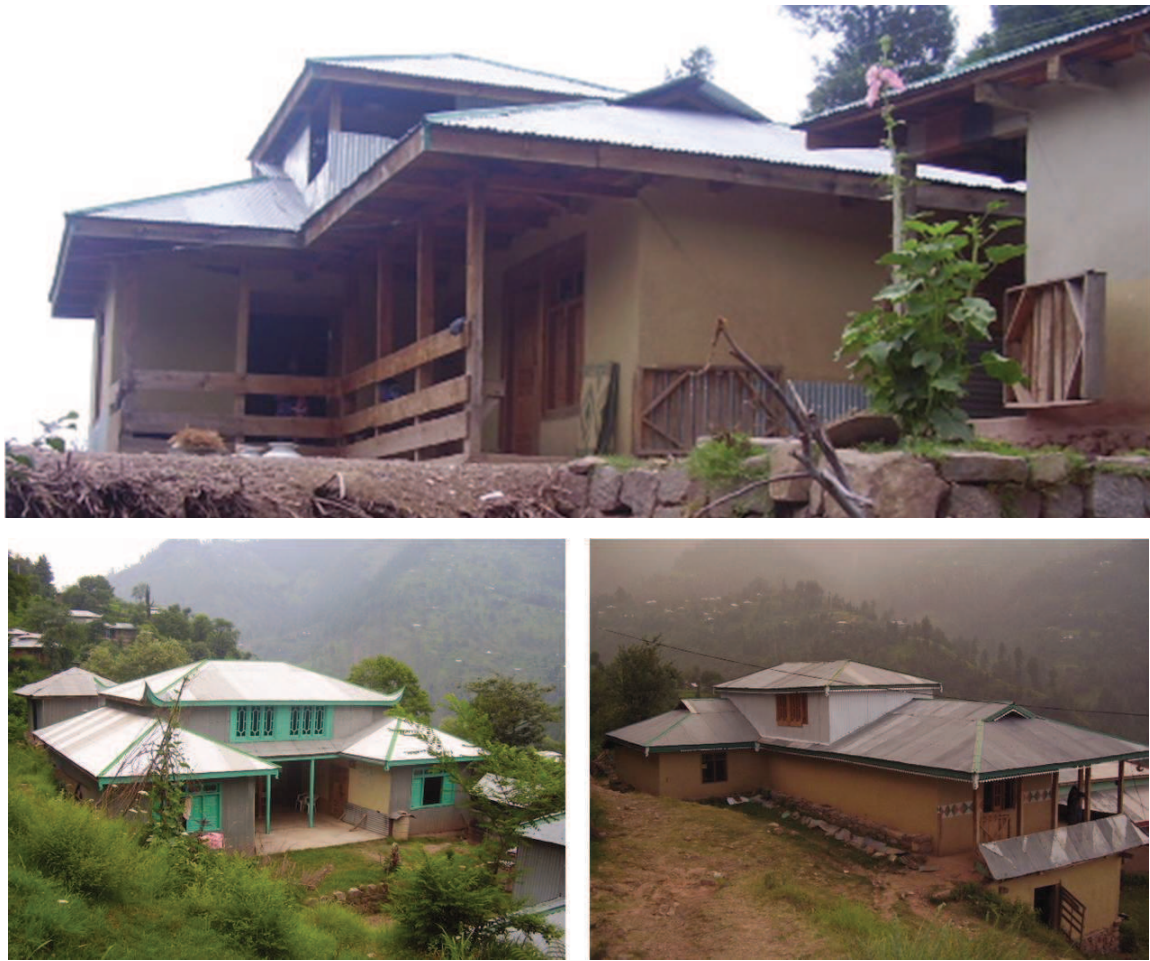
*Figure 6.38* — Houses with prominent break and combination of different roofs. Source : S. Abidi

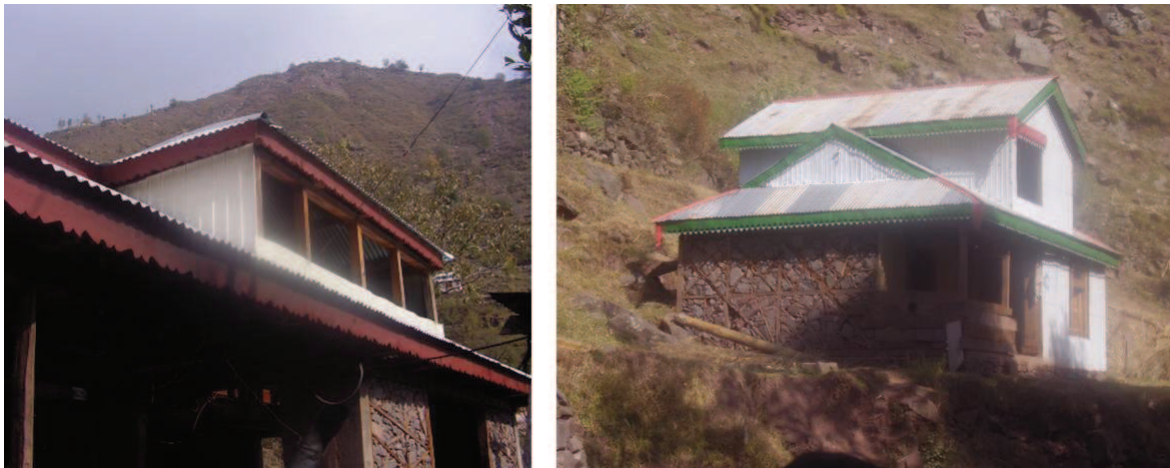
*Figure 6.46* — Tower roof houses showing dhajji dewari on ground floor. the upper structure is covered with CGI sheets and is distinctly framed out of ground floor. Source : S. Abidi

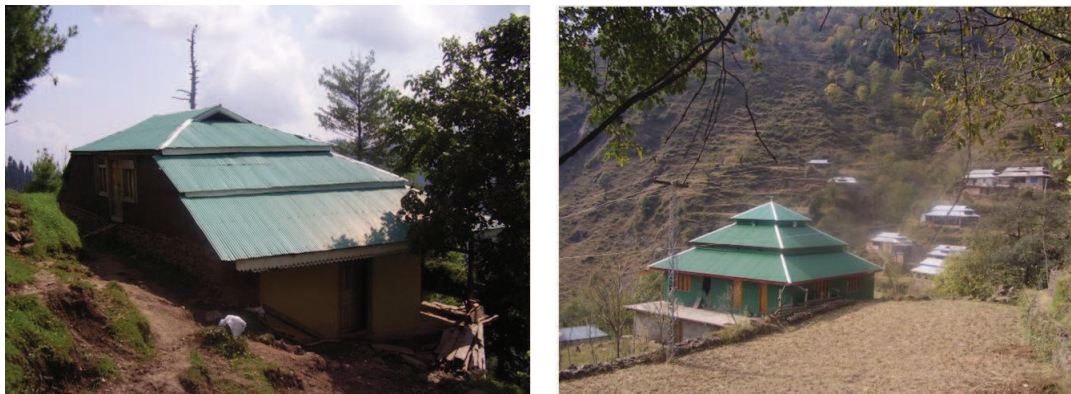
*Figure 6.72* — Although negligible break in the roof is evident, the span of the roof has increased the height of attic. Source : S. Abidi

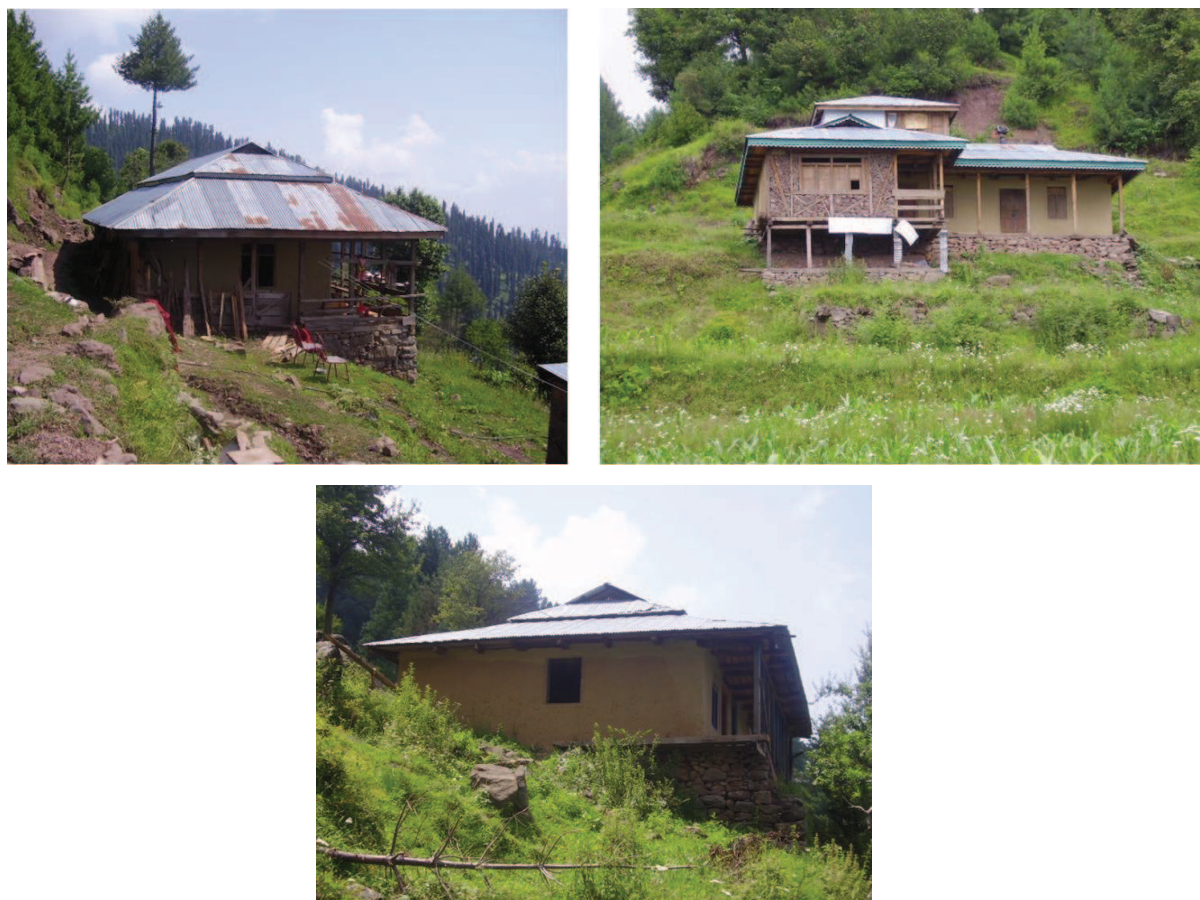
*Figure 6.83* — People have built on hazardous sites. Source : S. Abidi.

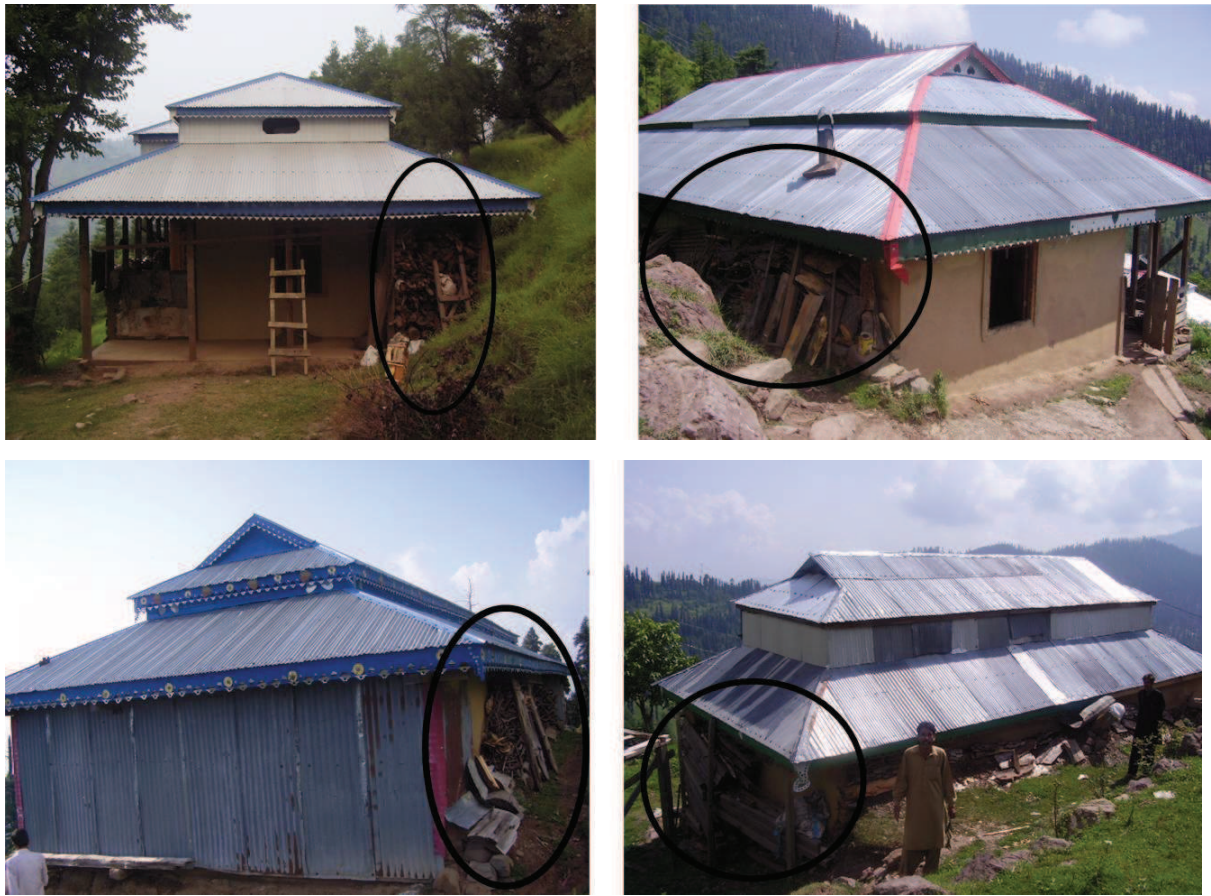
*Figure 7.16* — Timber is stored beside the dhajji wall hence making the structure susceptible.

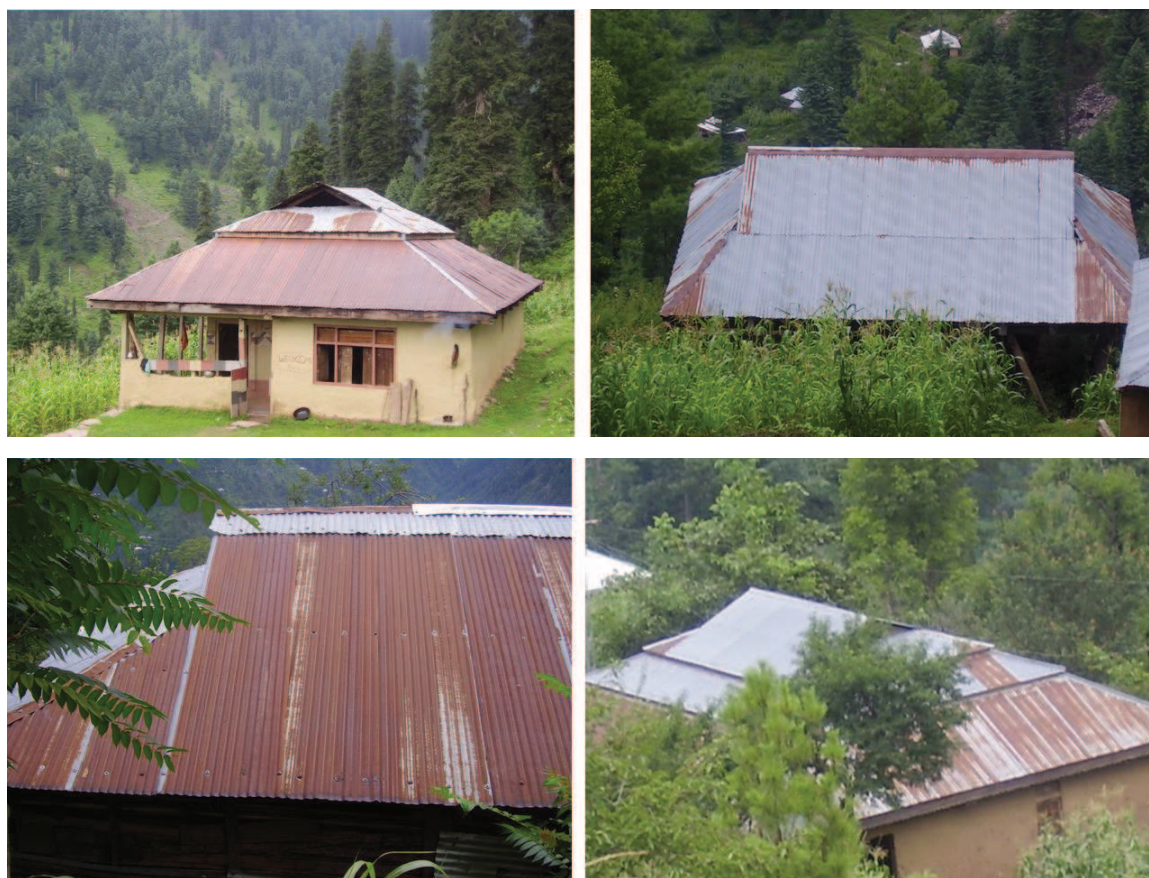
*Figure 7.19* — The reconstructed houses are experiencing corrosion. Source : S. Abidi

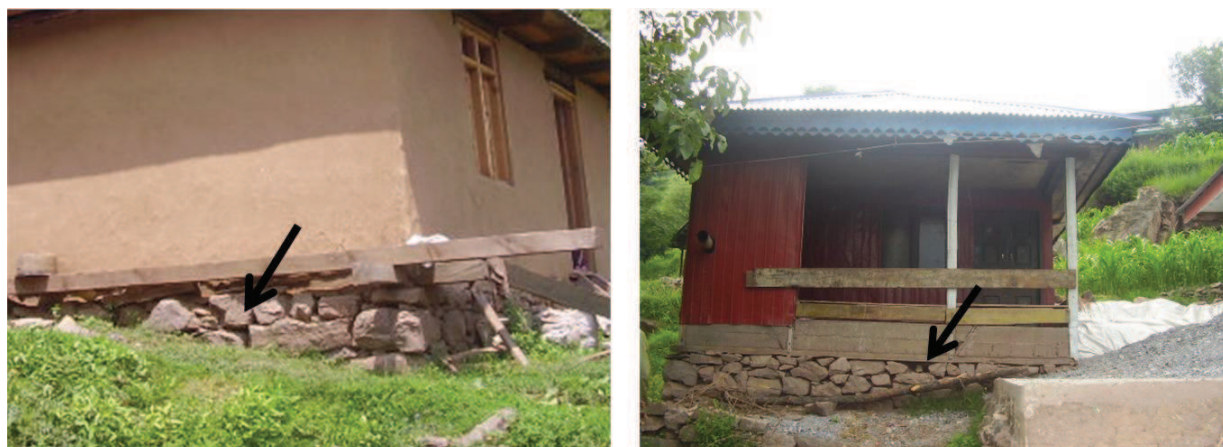
*Figure 7.29* — During surveys, gaps were found in the plinth. Source : S. Abidi.

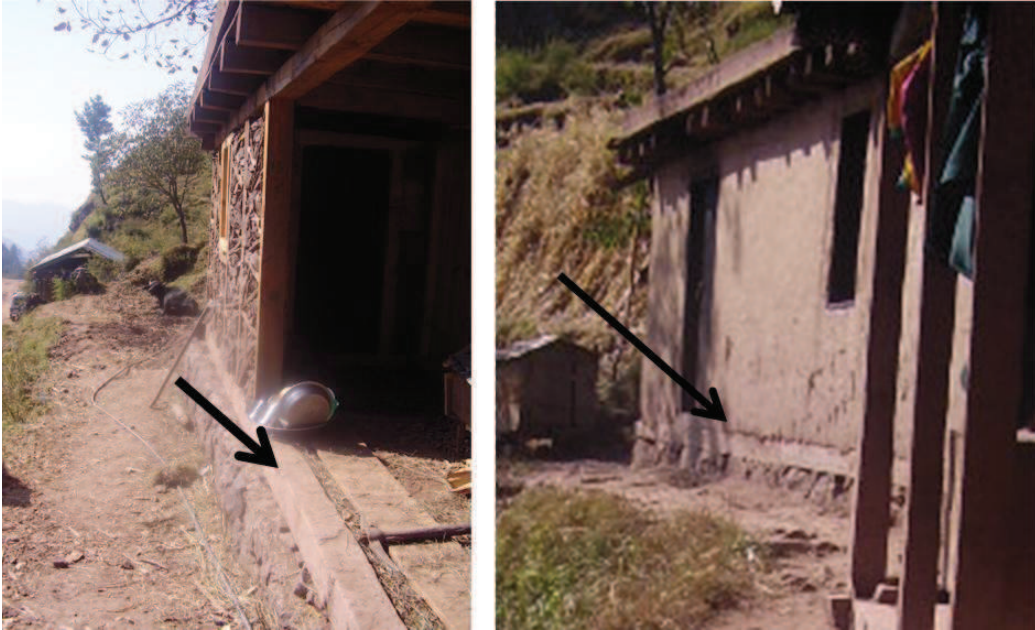
*Figure 7.30* — Base plate was found compliant in the reconstructed houses. Source : S. Abidi.

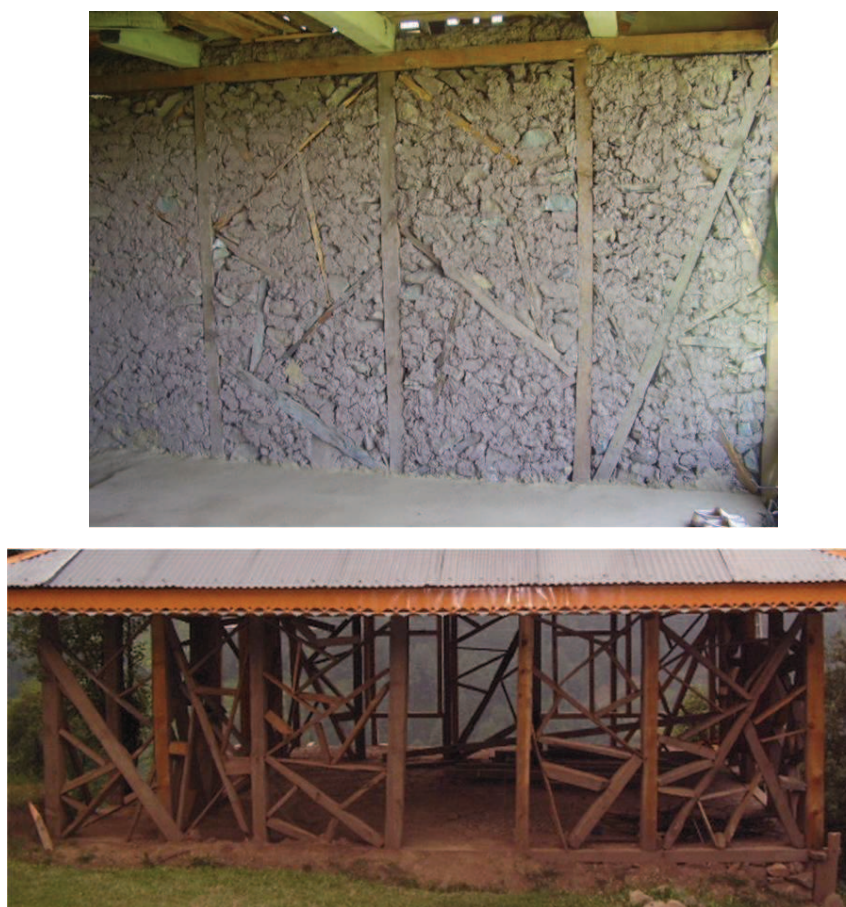
**Figure 8.23** — Retaining wall and bracing members issues. Source : S. Abidi

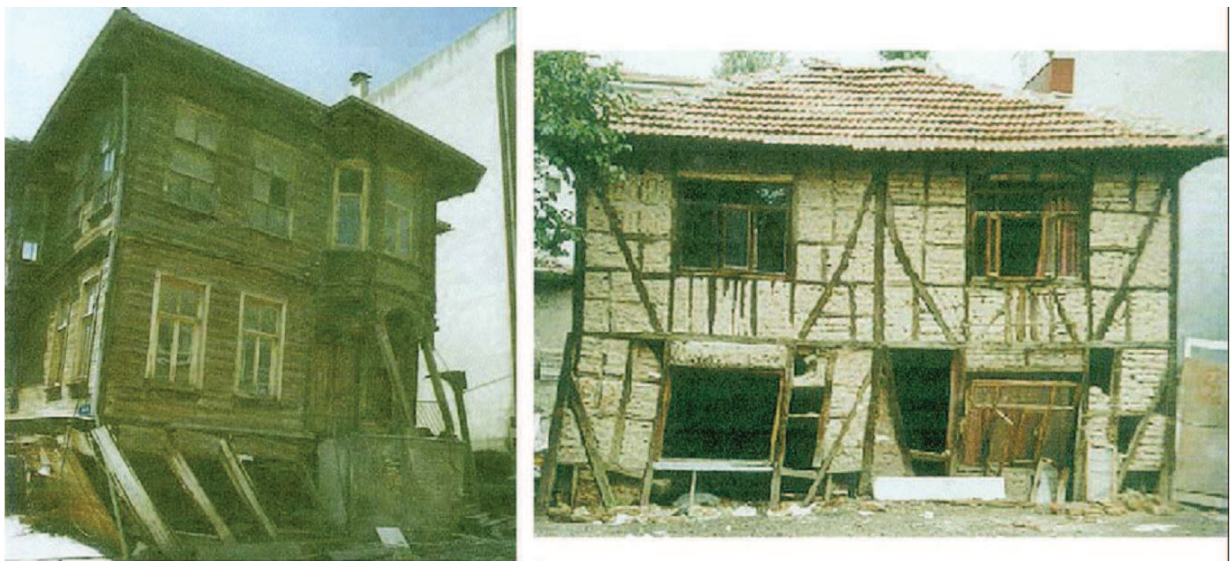
**Figure 8.28** — Heavily damaged traditional wooden buildings due to soft storey. Left : Large laterally displaced traditional building ([Bayulke, 2004]) ; Right : Laterally displaced traditional building ([et al, 1999])

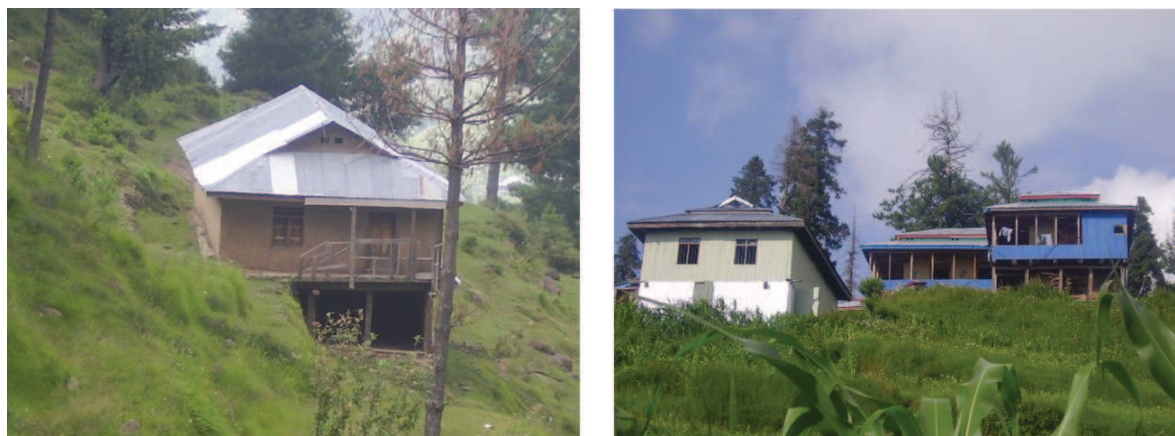
*Figure 8.29* — Soft storey houses found in AJK. Source : S. Abidi

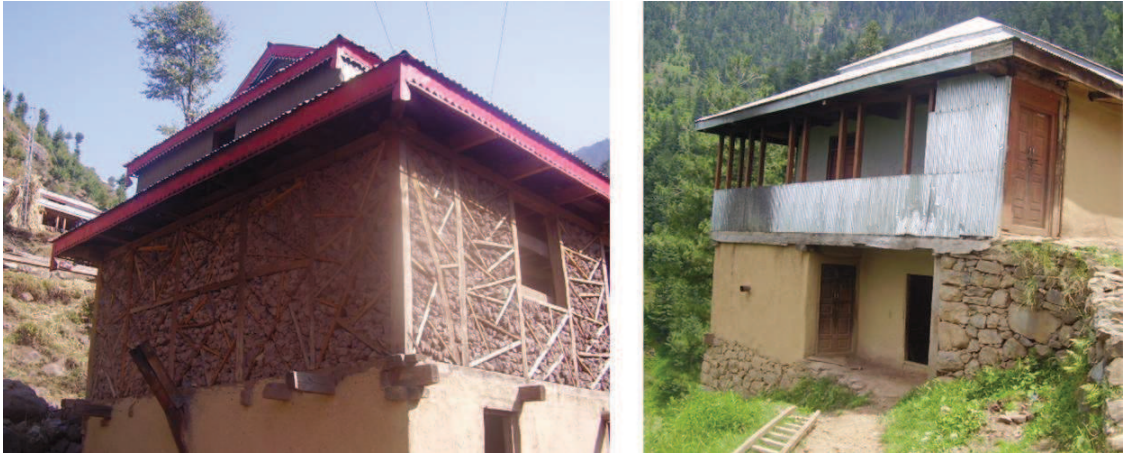
**Figure 8.30** — These houses gained ERRA funds for the ground floor area. First floors are constructed with own funds. The tower roof above is the indication of the changed construction culture of rural AJK. Source : S. Abidi

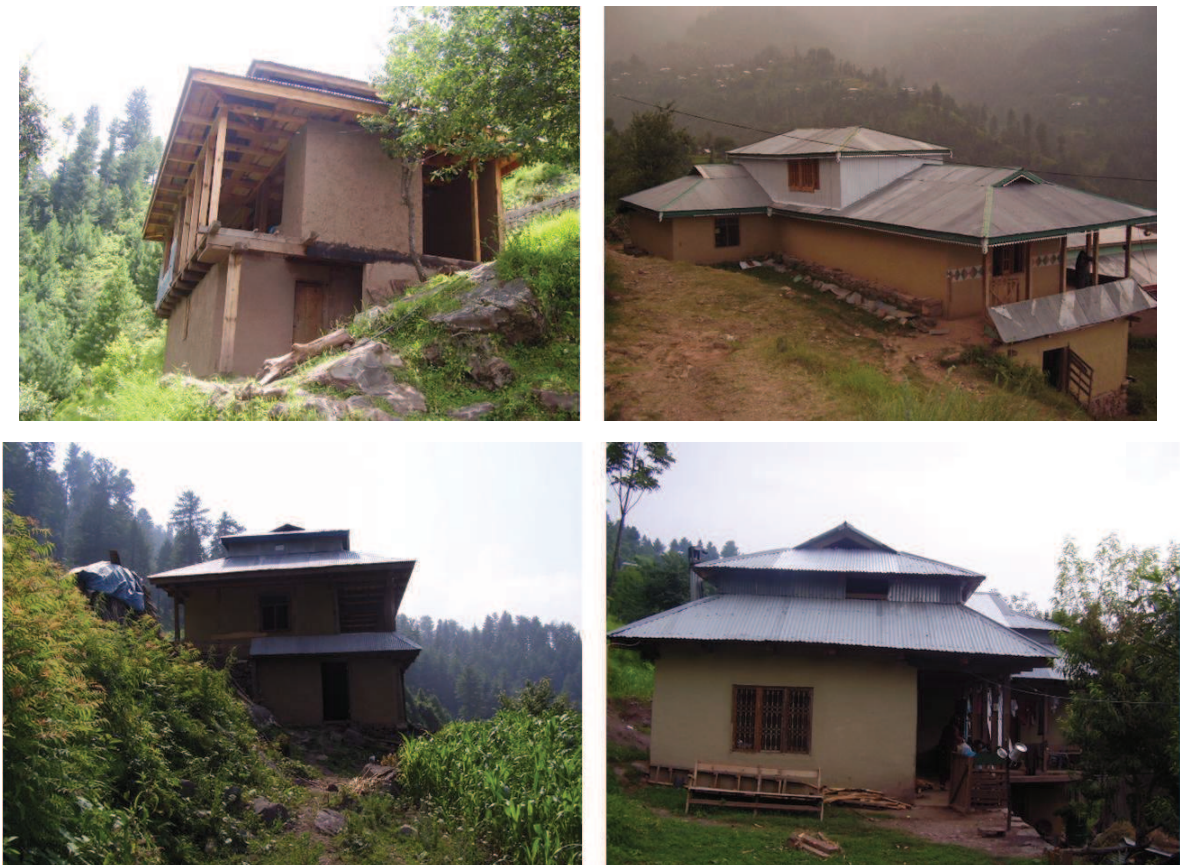
**Figure 8.31** — Houses built on hazardous sites or have improper retaining wall. Source : S. Abidi
