High human influence on beach response to tropical cyclones in small islands: Saint-Martin Island, Lesser Antilles

Virginie Duvat, Valentin Pillet, Natacha Volto, Yann Krien, Raphaël Cécé,
Didier Bernard

Virginie Duvat, Valentin Pillet, Natacha Volto, Yann Krien, Raphaël Cécé, et al.. High human influence on beach response to tropical cyclones in small islands: Saint-Martin Island, Lesser Antilles. *Geomorphology*, 2019, 325, pp.70-91. 10.1016/j.geomorph.2018.09.029 . hal-01924514

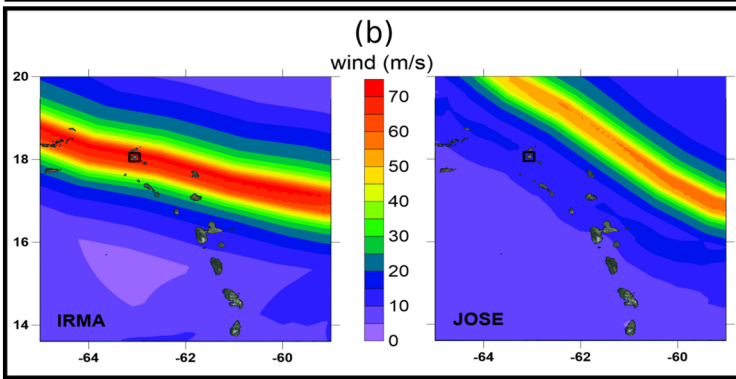
Figure 3

During the 2017 North-Atlantic cyclonic season, 17 storms, 10 hurricanes and 6 major hurricanes were observed. This season was characterized for the Lesser Antilles by three extreme hurricanes, Irma, José and Maria, associated with extreme sustainable wind speed values reaching or exceeding 250 km/h (Figs. 3a-c). The main features of these hurricanes are summarized in Table 2.

Three days after Irma, category 4 tropical cyclone José passed to the north at some 130 km from Saint-Bartholomew and Saint-Martin (Fig. 3a), without causing significant damage. The maximum significant wave heights still reached about 5 m off the eastern coast of Saint-Martin, according to the numerical results obtained with SCHISM-WWM (Fig. 3d-right), but the

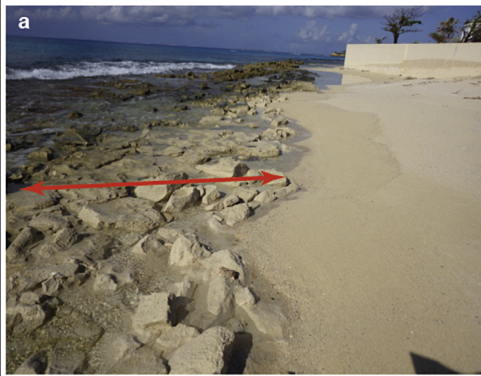
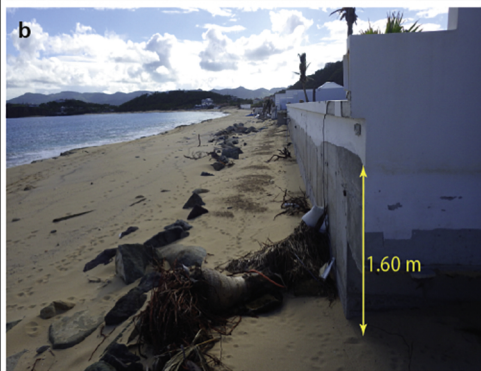
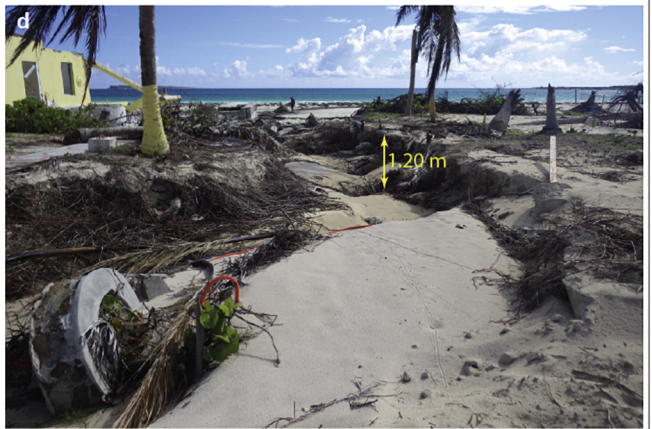
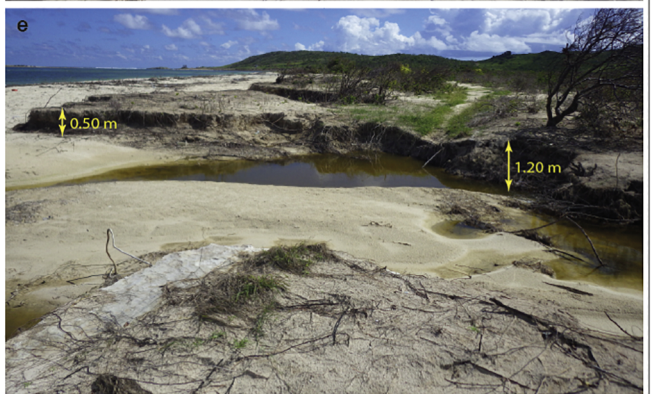
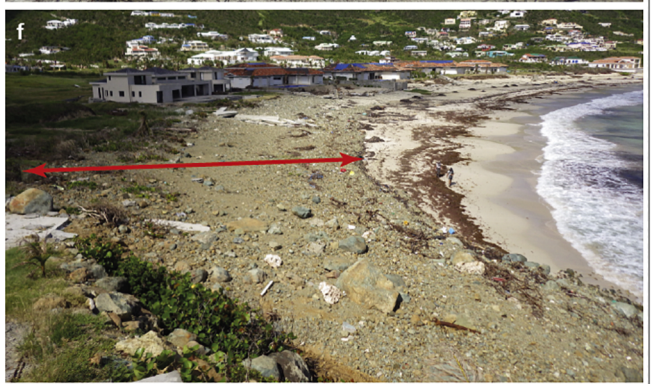
Figure 8

Generally, erosional features predominated in the beach, upper beach and sand dune edge areas (Fig. 8 and SM2). At most sites, beach lowering was revealed by the exhumation of buildings' foundations and of previously buried beachrock slabs (Fig. 8a). The highest values of beach lowering, reaching up to 2 m locally, were observed in front of buildings and seawalls protruding onto beaches (e.g. Red Bay, Fig. 8b). Although beach recovery had started at the time of our field visit, the erosional impacts of the cyclones were still clearly shown first, by the erosion scarps cut into the upper beach (generally 0.30 to 0.80 m high) and sand dunes where the latter occur (with scarps ranging from 1.50 to 4 m in height at Longue Bay and Red Bay; Fig. 8c), and second, by the exhumation of the root system of the destroyed vegetation over a 5 to 40 m-wide coastal strip (Figs. 8d, 8e). The height of erosion scarps was proportional to land elevation, thereby varying significantly between low-lying barrier beaches, where it ranged from 0.30 to 0.60 m, and beach-dune systems, where it reached up to 4 m. In places, scour holes and soil scouring were also noted (e.g. at Petites Cayes Bay, Orient Bay, Embouchure Bay and Guana Bay; Figs. 8e, 8f), which extended from the upper beach to inner land areas over distances ranging from a few metres to around twenty metres. On the most affected eastern site, namely Orient Bay, wave attack even led to the formation of a 1.20 m-deep and 15 m-long trough, extending transversally to the shoreline from the upper beach to inner land areas (Fig. 8d).

Shoreline hardening also had impacts on erosional and accretional cyclone-driven processes. Beach lowering was greater in front of seaside property walls and seawalls, where it reached up to -2 m (Figs. 8b, 10c, 10d), compared to non-built shoreline sections where values <0.80 m were observed. In addition, where sediment transport pathways were obstructed by human constructions, sand accumulation only occurred in devastated buildings and swimming pools (Figs. 10f-g), and in gaps between buildings (Fig. 9b). Where human constructions were continuous along the shoreline, sediment deposition on upper beaches and over inland areas was either absent or very limited (Fig. 10a). At the time of the field visit, in settled residential areas, invading sand deposits had been cleaned and raked-up into piles by residents (Fig. 10g). Longitudinal constructions therefore exacerbated the erosional impacts of the cyclonic waves on beaches, while limiting sediment deposition on upper beaches and over inland areas.

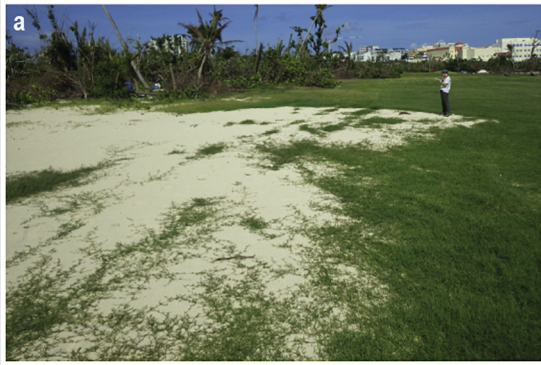
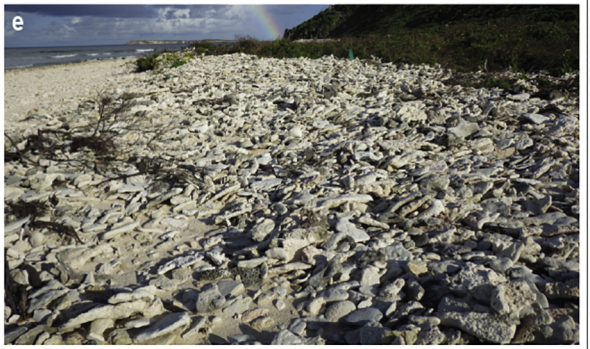
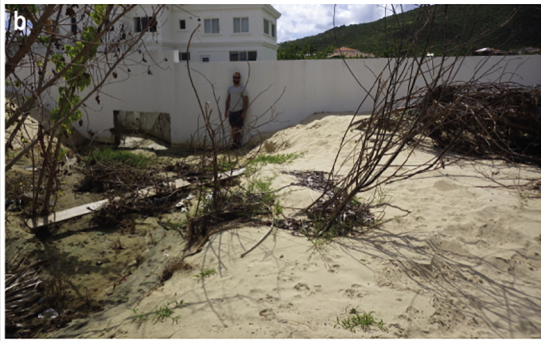
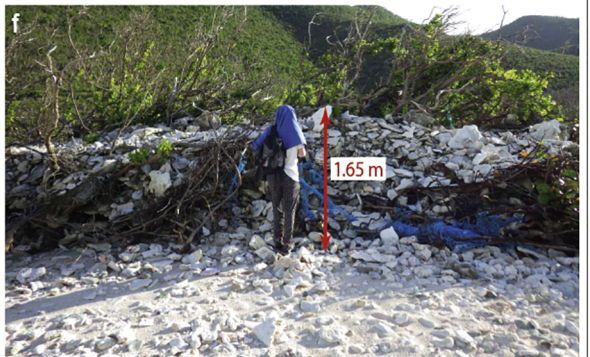
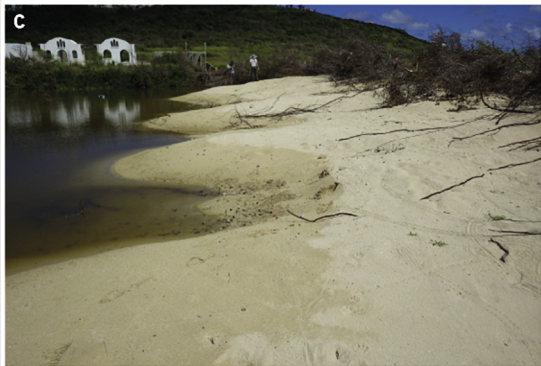
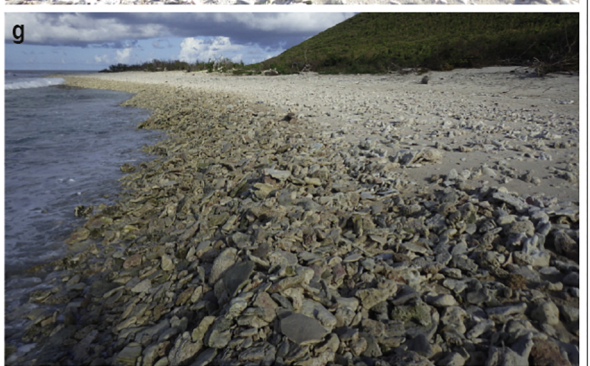
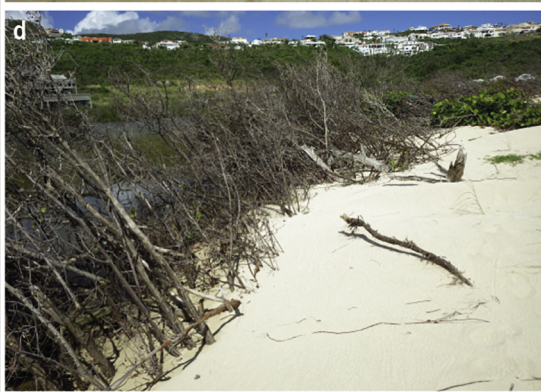
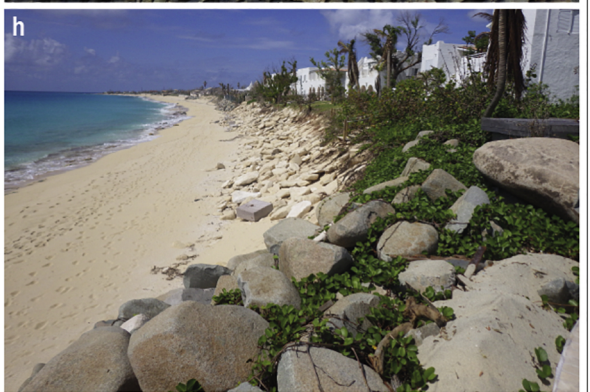
Figure 9

While erosion predominated on beaches and upper beaches, sand accumulation prevailed in inner land areas as a result of overwash where no obstacle, neither natural (i.e. dense vegetation) nor human-built (i.e. buildings and engineered structures), obstructed sediment transport pathways. Extensive sand sheets indicating massive sediment transfer from beaches to

inner land areas were the most common feature observed (Fig. 9, SM3). In open areas, sand deposits penetrated inland over great distances, i.e. 135 m, 105 m and 75 m from the pre-cyclone vegetation line at Simpson Bay, Nettle Bay (west) and Mullet Bay, respectively (Fig. 9a). At most sites, the maximum thickness of these sand sheets ranged from 0.10 to 0.80 m (Fig. 9b). It reached the maximum value of 2 m on the highly-exposed eastern coast at Gibb's Bay (Fig. 9d). Moreover, at two sites (i.e. Red Bay and Gibb's Bay), barrier beach overwashing by the cyclonic waves caused sediment deposition in the inner lagoon, where sand lobes formed (Fig. 9c). In addition, at one site (i.e. Embouchure Bay), a new channel (maximum dimensions of 15 m x 75 m) formed across the barrier beach. Of note, on the north-eastern back-reef beaches (namely Petites Cayes Bay and Petites Cayes Beach), the substantial transfer to the coast of coral debris (primarily shingle and rubble, and secondarily blocks) led to the formation of crescent-shaped deposits at the base of the beach (Fig. 9g) and of a 0.80 m-high, 20 m-wide and 60 m-long beach ridge on the upper beach (Fig. 9e). Additionally, on highly eroded beaches bordered with beachrock slabs, the dismantling and landward transfer of fragments of the latter caused block accumulation at the beach surface and along the erosion scarps cut by cyclonic waves in upper beaches and sand dunes (Fig. 9h).

a Cyclone-generated 2 to 8 cm-thick sand sheets extending over a maximum distance of 75 m from the pre-cyclone vegetation line, central part of Mullet Bay. b 0.80 m-thick sand deposits recorded in open areas between buildings at Guana Bay. c and d Gibb's Bay. c Sediment deposition resulting from wave overwashing of the 40-50 m-wide barrier beach. Sand lobes formed along the entire lagoon-side shoreline. d Sand deposition against the natural vegetation in the inner part of the barrier beach. e, f and g show accretional features observed on Petites Cayes Beach. e The beach ridge that formed at the top of the shrubby vegetation, as a result of the transfer of coral debris and blocks from the fringing reef to the beach. f Major role of the dense coastal vegetation in trapping coral debris and blocks. g Crescent-shaped shingle deposit structure that formed at the base of the beach. h Beachrock fragments' accumulation against cyclone-generated erosion scarps cut in Longue Bay sand dunes. These deposits result from the dismantling of exhumed beachrock slabs that can be seen in the wave breaking zone on the same photograph.
