**The Qalhât Project - Preliminary report on the fourth
season of excavations of the French mission
(25/10-12/12/2011)**

The Qalhât Project

Preliminary report on the fourth season of excavations
of the French mission
(25/10 -12/12/2011)

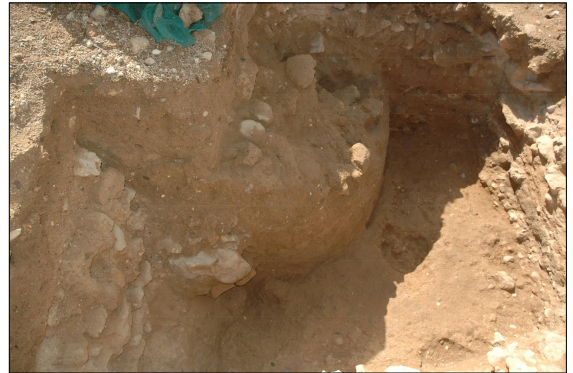
Onto this original smoothed wall construction a second layer of stones was at some point added (fig. B12_S22/2 Original qibla wall before restoration). Though, this time the face is not smoothed with plaster. The second phase holds strong plaster inside and in between stones, but does in this trench not coat the entire wall as the case is on the base. Moreover, the second phase does not connect to the mihrab wall, contrary to the first. This does however not imply that the second phase is of exceedingly later construction. Rather, the impression is it is added contemporary to the first, but with another batch of plaster; the two plasters drying with some time difference. In the excavation of 2008, further to the north this second phase is though covered with plaster; why we can assume the case was along the entire wall. The lack of plaster in the connection to the mihrab wall base must thus be explained with erosion by wind and water.

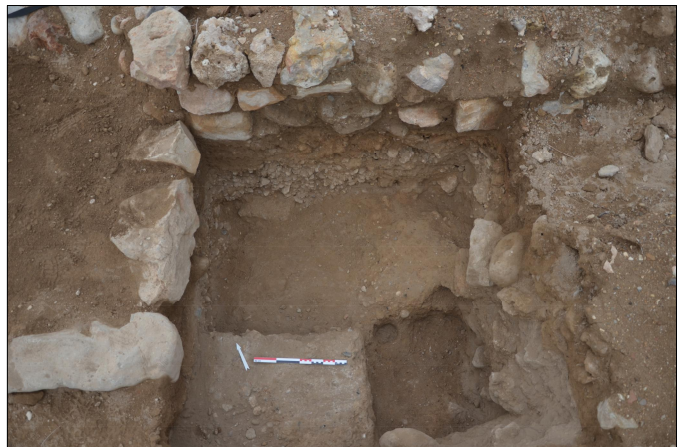
The wall B12-062 is directed west/east. It is parallel to the wall of terrace B12-037 in approximately 8m in the North (**fig. B12_S23/2 Wall B12_062**). At the level of the sounding 23 only ones three wall sill plate are still existing. They consist of limestone and pebbles of a module going of 0,20m to 0,30m bound with some mortar of orange earth. This wall is built on the arase of the pillar of the phase 2 and that of the low wall of the phase 3. It is however wider than both elements of the previous phase what explains the projection observed during the excavation. The height of the foundations of this wall is 11,25m. The upper layer of the sounding 23 corresponds in priori to the destruction of the wall of terrace B12-062. At the end the sounding 23 shows the layers of occupation of the phases 3 and 4 disappeared in this place but could remain somewhere else.

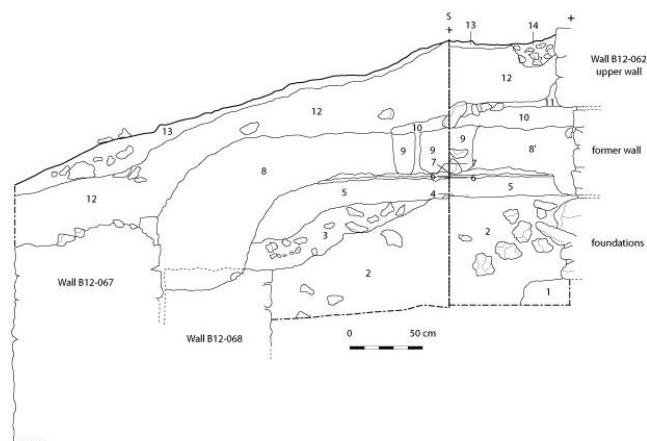
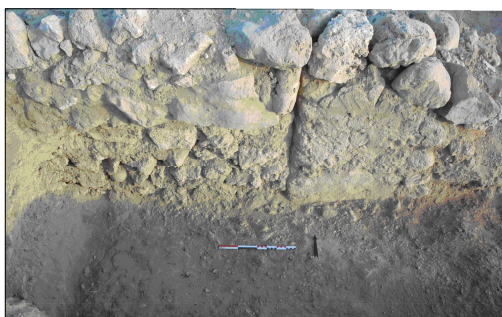
The enlargement of the sounding towards the west allowed us to study the wall B12-062 for almost 3 meters long. This wall appears to have been built in at least three different phases (**fig. B12_S21/3 south and west sections of S21W**) from the surface, and starting from the west corner, three rows of quite big stones (that are also visible in Sounding 23) lean on an anterior phase of the same wall, less wide and made of smaller nodules, mainly coral blocks (average 10-15 centimeters). This former wall surmounts a 50 centimeters layer of very coarse foundation.

At 1 meter, a massive coated pillar (*ca.* 70-80 centimeters wide) stands on top of the same type of rough stone foundation (both foundations might be contemporary as they look very similar), and seems to join together several structures, raising the question of its dating in the chronology of the different walls (**fig. B21_S21/4 Wall B12-062 before foundations and B12-068 had been uncovered: upper wall, former wall and plastered pillar**)

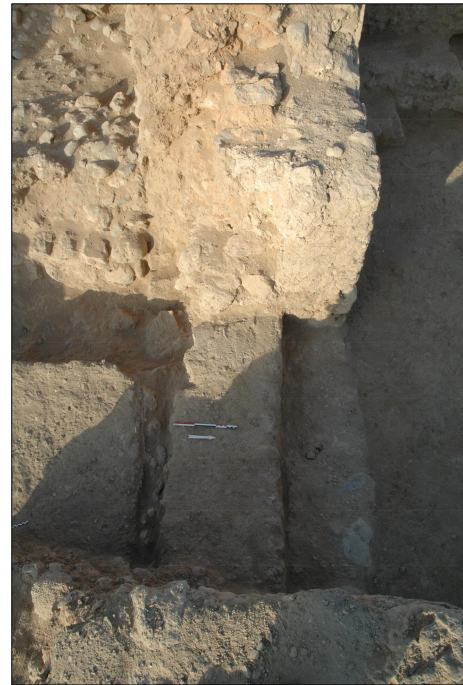
From the outside (fig. B94-19 Door and structure 045, 046 (doorstep) and 047 from the outside), the entrance area showed two structures, one on each side of the door. To the east, a 70 cm high wall seat (structure 047) lay along wall 048, starting from the doorstep. Its eastern extremity is unknown but a stone collapse had damaged the top of it, about 3m east of the door. This wall seat was built against wall 048 and was totally covered with hard gray plaster.
