Photogrammetry for the preparation of archaeological excavation. A 3D restitution according to modern and archive images of Beaufort Castle landscape (Lebanon)

PHOTOGRAMMETRY FOR THE PREPARATION OF ARCHAEOLOGICAL EXCAVATION. A 3D RESTITUTION ACCORDING TO MODERN AND ARCHIVE IMAGES OF BEAUFORT CASTLE LANDSCAPE (LEBANON)

CIPA Special Session
Low Cost Systems in Recording and Managing the Cultural Heritage

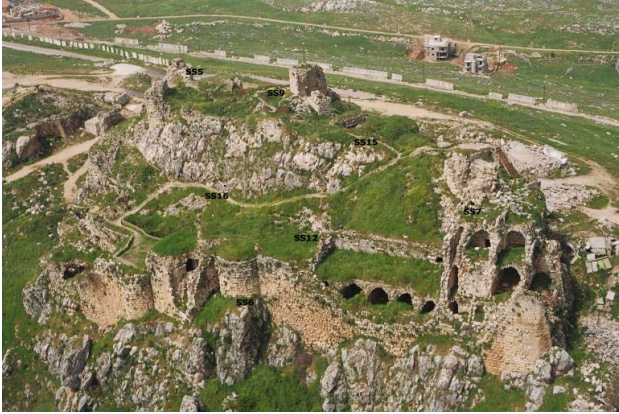
Figure 1. Recent aerial view of the Beaufort castle (Nikon F3, 2003)

After the end of the war, access to the castle became secure. There was a need to manage to realize a complete documentation of the unreachable parts of the castle (basically the eastern elevation over the valley). That's why a helicopter flight was scheduled in 2003. Aerial oblique views were taken (figure 1) in that flight. They were composed of digital images (Nikon Coolpix 5000, 2560x1920 pixels) and film-based small format color slides (Nikon F3, Nikkor lenses, 55 mm, scanned at a resolution of 3000x2000 pixels). Last but not least, a complete documentation requested terrestrial views of the castle; digital images and again film-based small format color slides were taken (figure 5). Thanks to this exhaustive documentation, three-dimensional restitution was possible. All the modern documentation was produced in one day.

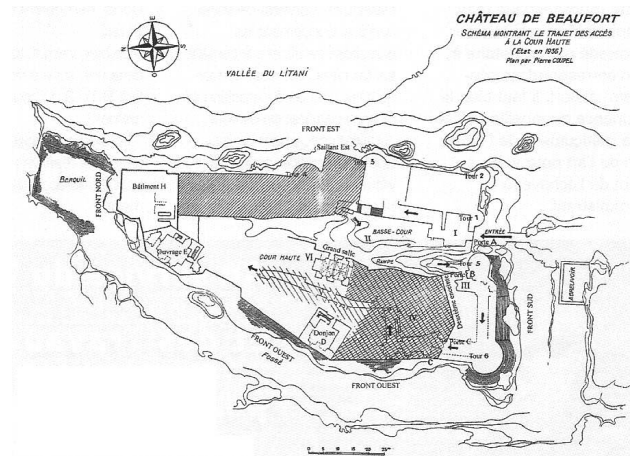
Figure 2. Map of Pierre Coupel (Architect) drawn up during the Deschamps survey (1936)

by the architect Pierre Coupel showing the means of access to upper courtyard of the castle (figure 2). After the independence of Lebanon in 1943, extensive works began.

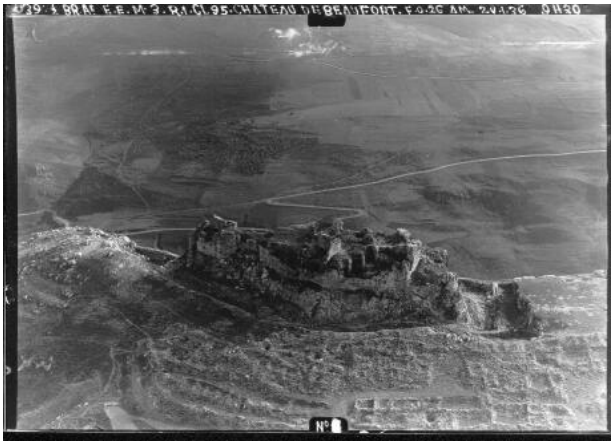
Figure 3. Example of archive photo of 1936 (IFPO), showing in the foreground the archeological hidden remains

b- Serie 2: These are photos still existing in the *Institut Français du Proche-Orient* (IFPO) archives (figure 3). All these photos were taken by the French air force of the *Levant* between the years 1930 and 1936. We were able to get duplicates (contact prints) of negatives at a size of 13cm x 18cm, scanned on a desktop scanner.

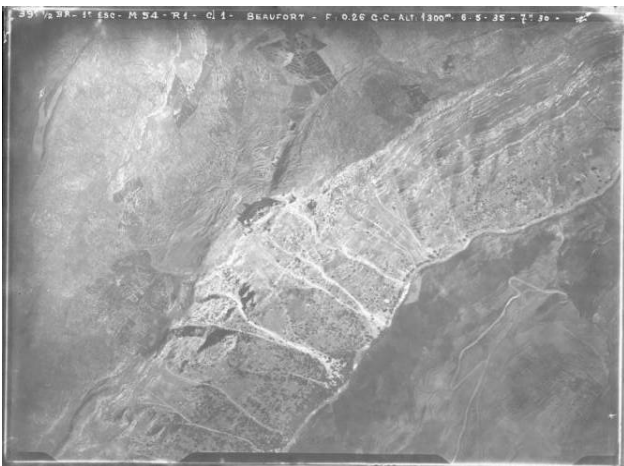
Figure 4. Example of archive photo of 1935 (DGA, area of Beaufort's castle), showing the castle (in the middle) and the landscape (focal length 26cm, flying height 1300m above ground, 2000m above sea level)

c- Serie 3: These are photos existing in the archives of the DGA. All these photos were taken by the French air force of the *Levant* between the years 1931 and 1936. They are vertical views (figure 4). Only contact prints at a size of 13cm x 18cm are available; the original negatives were not found. Those contact prints were scanned.

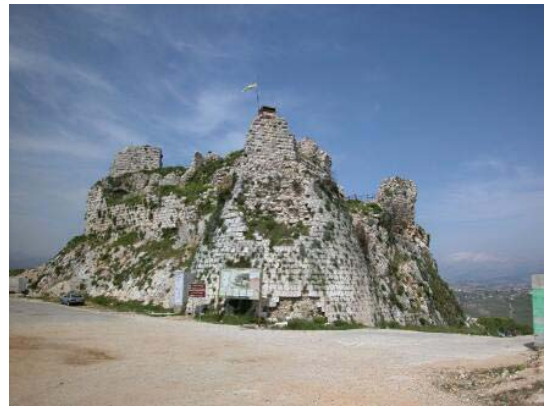
Figure 5. Recent terrestrial digital image (modern documentation, Nikon Coolpix 5000, 2003)

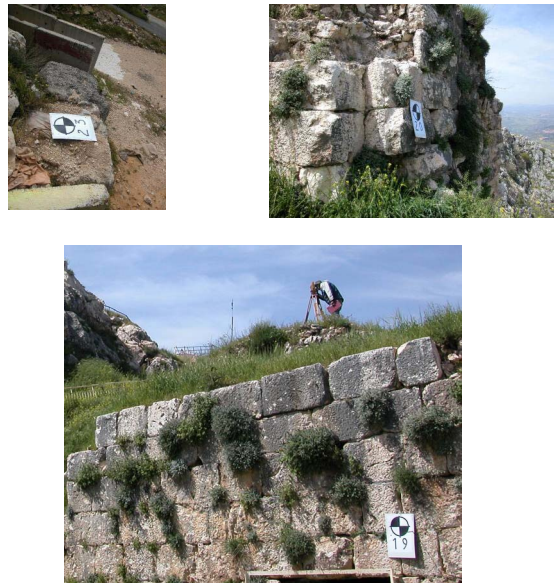
Figure 6. Examples of targets used for the control points

On that same day, while photos were being taken, a team of geodetic surveyors installed reference points on the ground and elevations of the castle. These points (figure 6) were easy to identify on the photos. A total-station was used by the surveyors to measure the reference points. This generated three-dimensional coordinates for these points.

More than 130 images were realized in spring 2003 with the Nikon F3 and Nikon Coolpix cameras (a hundred images on the ground and about thirty in the helicopter). A first block of 18 oblique views of the castle was oriented in June 2003 using the control points materialized on the ground by targets (figure 6). Standard deviations of about 10 cm on the co-ordinates of the points measured on the images have been obtained. We then selected in this project a set of points simultaneously visible on the images of 1931-1936, in order to define approximations of the photogrammetric parameters, and to calculate a block based on a selection of these archive images.

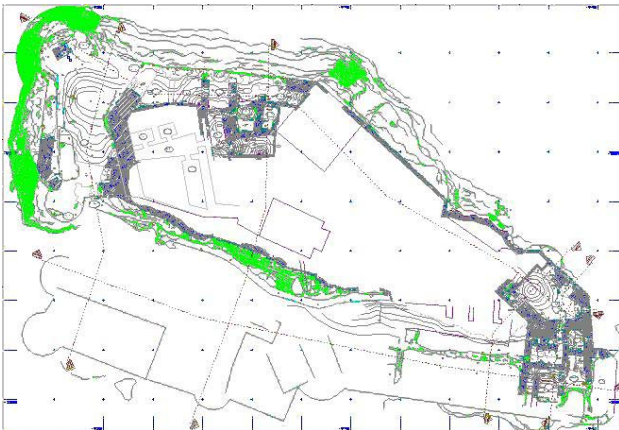
Figure 7. Example of 2D AutoCAD map from the tacheometric survey of 2002 (level 4 of the castle).

The first topographic surveys conducted during the preliminary study were not very accurate due to the difficulties encountered in trying to access some of the areas of the castle. These first surveys were performed using GPS and tacheometric techniques. The AutoCAD maps (figures 7 and 8) used to establish the tender documents for the restoration of the castle were based on these surveys. The inaccuracies of these surveys did not represent a major problem for the restoration of the visible areas of the castle. However, these inaccuracies prevented us from computing the exact position of the archaeological hidden remains. We plan to generate a new AutoCAD documentation showing the surroundings of the castle and the archaeological hidden remains that should be dug out (§5).

From the block of images previously oriented, the restitution initially carried out in 2D in Autocad (e.g. fig. 7 and 8) will be enriched by a 3D restitution corresponding to the objectives of the documentation. We are then able to calculate and draw the visible structures from the aerial and terrestrial photographs of 2003 by digitalizing on the images. One will proceed in an identical way on the archive photographs to measure the archaeological structures currently covered by the remains of the war currently embanked or destroyed (fig. 10), or to plot in 3D parts of the castle (see §6).

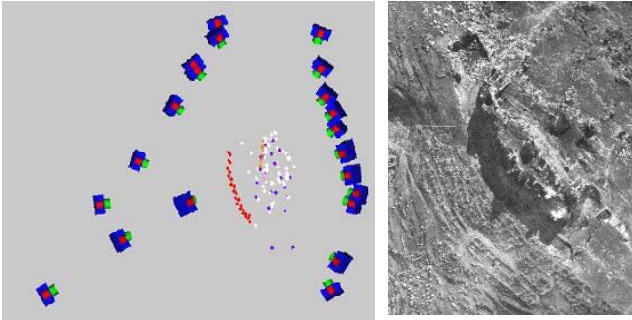
Figure 9. Overview of the camera stations and the block configuration after the exterior orientation. At the right: a vertical view of 1935 allowing the location of the camera stations.

At this stage, the two separately calculated projects are referred to the same reference system. The process of merging (of several projects) proposed in the PhotoModeler software allows

the restitution of three-dimensional elements simultaneously on the photographs of 1936 and 2003, and to superimpose and display these results within a unique project.

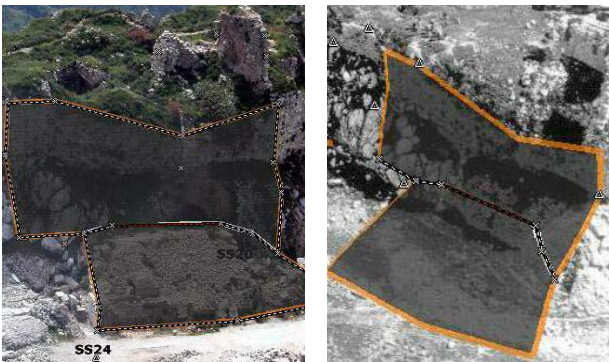
Figure 10. Restitution of the embankment areas: on the left, the boundary of the embankment is marked on a photo of 2003 and on the right, the corresponding surface is projected on an archive photo of 1936

The superposition of the two restitutions makes it possible to highlight the areas of interest (figures 10 and 11) for archaeological work and to estimate work of civil engineering (fill, cubature, rebuilding, etc).

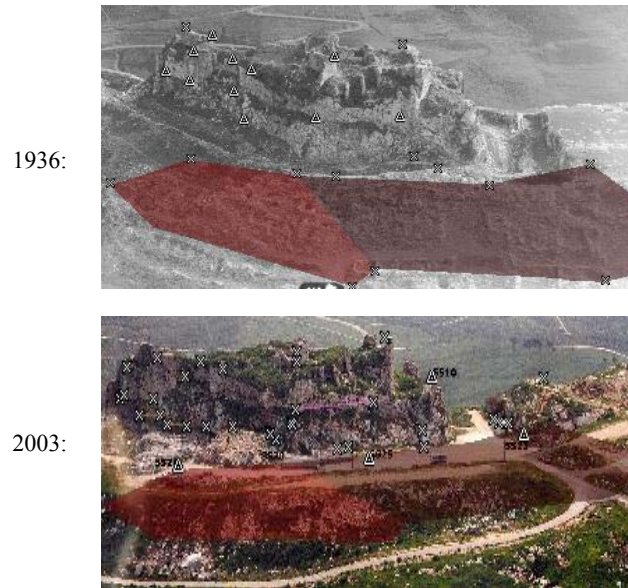
Figure 11. Archaeological structures are measured on the archive images of 1936 and the corresponding surface is shown on the photos of 2003

either from the images of 1936, or of those of 2003. From the resulting 3D photomodels, orthophotos can be calculated for the two periods, as e.g. for the frontages of the castle or the installations around the site covering the archaeological structures (fig. 11).

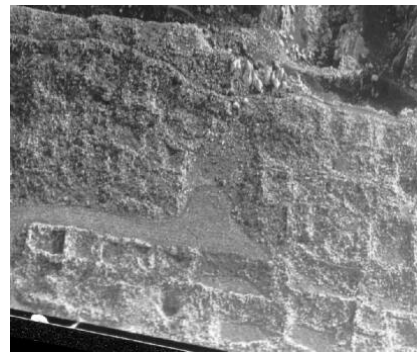
Figure 12. Example of orthophoto of the archaeological structure (computed from an archive image of 1936).

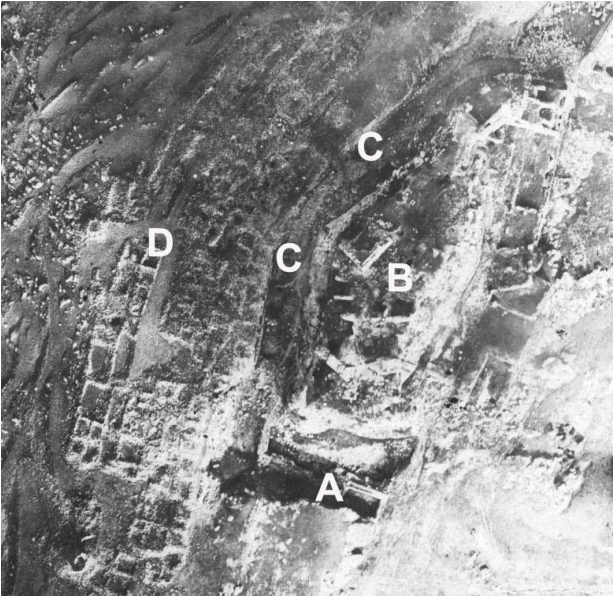
Figure 13. Vertical archive view showing some studied parts

The study is currently focused on different parts of the castle (figure 13). For some of them (as courses of bricks or stoneworks "label B"), a 3D restitution of both archive and recent images is possible.

Parts recovered by embankment are modelled from only archive images (watering place "label A", counterscarp "label C" and archaeological remains on the western part of the castle "label D").

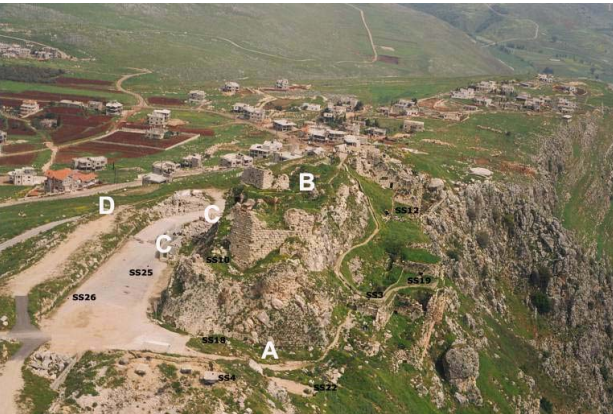
Figure 14. Recent image showing the surroundings of the castle and the current constructions
