## Can flood risk management restore ecogeomorphologic functioning of fluvial margins along the Rhône River (France, SE)?

4<sup>th</sup> ECRR Conference on River  
Restoration  
Italy, Venice S. Servolo Island  
16-21 June 2008

## CAN FLOOD RISK MANAGEMENT RESTORE ECOGEOMORPHOLOGIC FUNCTIONING OF FLUVIAL MARGINS ALONG THE LOWER RHÔNE RIVER (FRANCE, SE)?

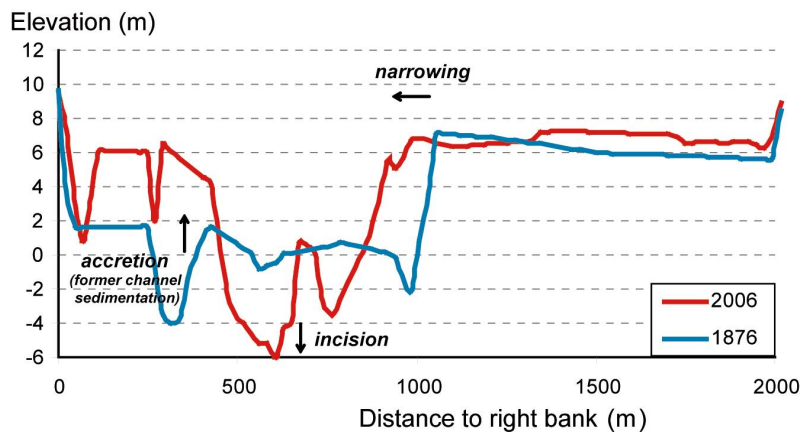
Figure 2: Channel cross sections at the kilometric point (kp) 275.5 in 1876 and 2006. Main changes are illustrated here: channel degradation and narrowing, sedimentation in former channels.

Historical data analysis (old maps and surveys) clearly demonstrate that the lower Rhône River underwent several changes in channel geometry and bank position over the last 150 years (channel incision and narrowing, former channel sedimentation, bank accretion). For example, at the kilometeric point (kp) 275.5, the channel has undergone a bed degradation of 2 m as well as a 500 m active channel narrowing between 2006 and 1876 (Figure 2). For the same discharge ( $5800 \text{ m}^3 \cdot \text{s}^{-1}$ ; 2 years return period), increase in water level at this point is close to 0.5 m.

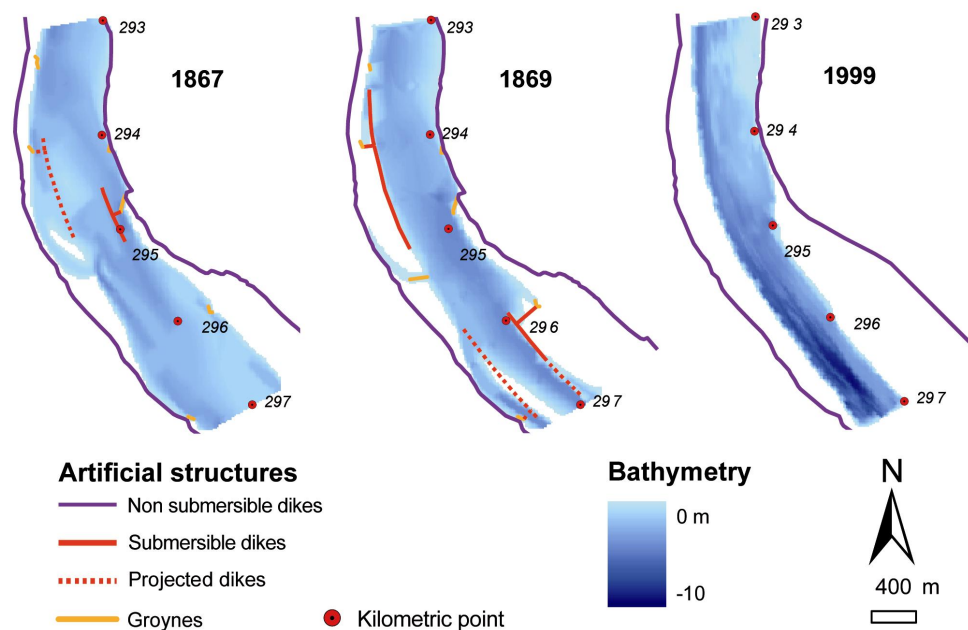
Figure 3: An example of regulation impact on channel geometry (incision and narrowing)

The regulation works (dikes, groynes...) built downstream of Beaucaire between 1870 and 1938, to improve navigation, also greatly participated to the observed adjustments. For example, some groynes and submersible dikes from kp 293 to kp 297 have been built since 1867 (figure 3) to limit lateral mo-

bility in concavities and to close the side channels. They resulted in a very fast channel narrowing of 80 m from 1867 to 1869.
