## The Roman baths at Karnak, between river and temple. Architectural study and urban context

Mansour Boraik, Salah Al-Masekh, Thibaud Fournet, Pauline Piraud-Fournet

## The Roman Baths at Karnak, Between River and Temples

### Architectural Study and Urban Context

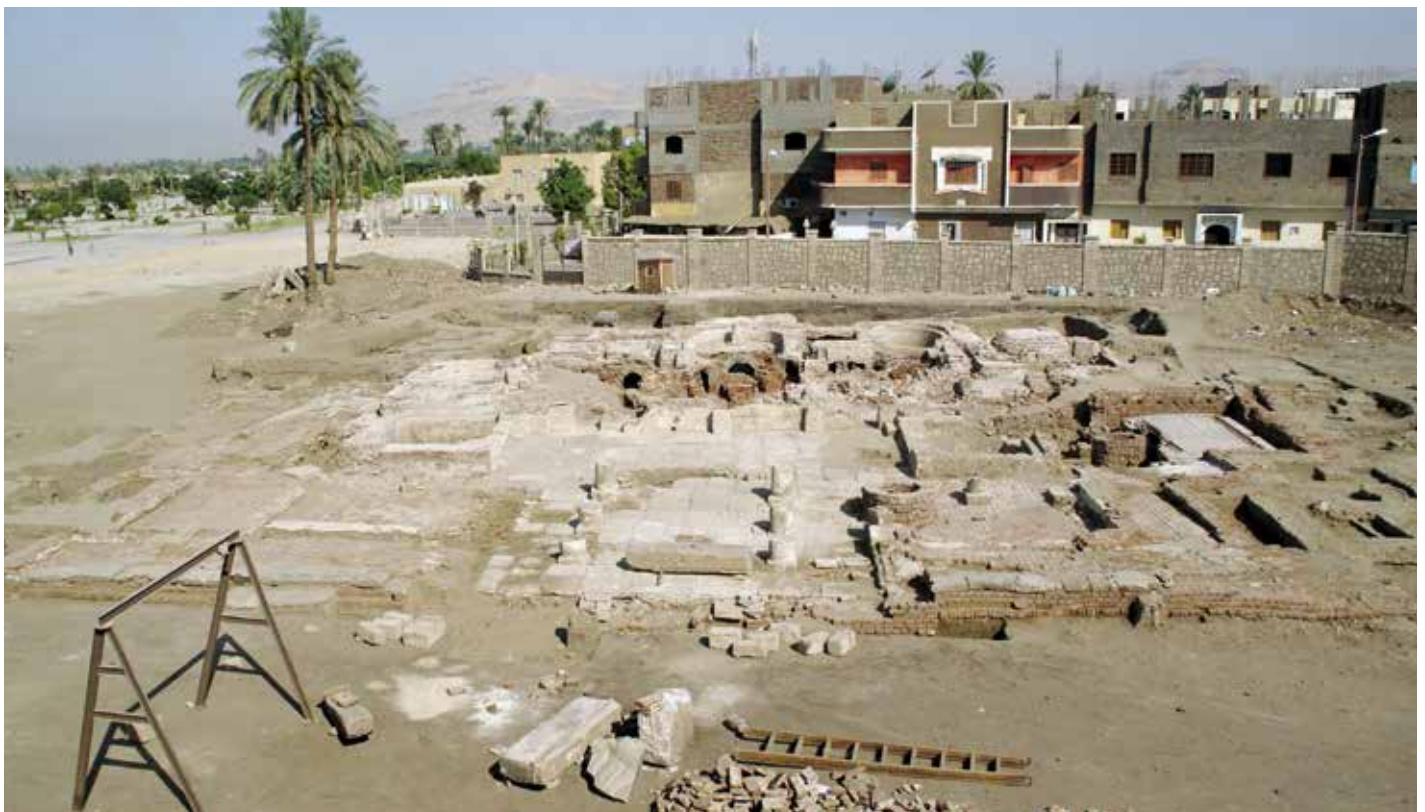
Fig. 2. General view, westward, of the Roman baths (© M. Vanpeene 2012).

The bath building covers an area of approximately 1440 m<sup>2</sup> (37 × 39 m, the bathing sector and its ancillary rooms occupying about 1200 m<sup>2</sup>). It is built almost entirely of fired and mud bricks (fig. 2), from the foundation to the vaults, some lying in their position of collapse when discovered.<sup>5</sup> As it stands today, in its last state, the construction had a relatively symmetrical plan along a central east-west axis. The main entrance is to the east, leading to a central courtyard and a large room ending with an apse to the west (fig. 3). Probably accessed from a street parallel to the enclosure wall of the temple, the entrance leads to an area (A) composed of two courtyards (one with a portico, the other hypaethral), two cold pools and some additional rooms (cloakrooms, latrines). This cold area gave access to the heated section (B), located in the centre, consisting of three small rooms opening into three larger rooms. The western section (C) is devoted to the heating system, and the water devices (D) are grouped to the north (aqueduct, reservoirs, *sakieh*, elevated tank)<sup>6</sup>.

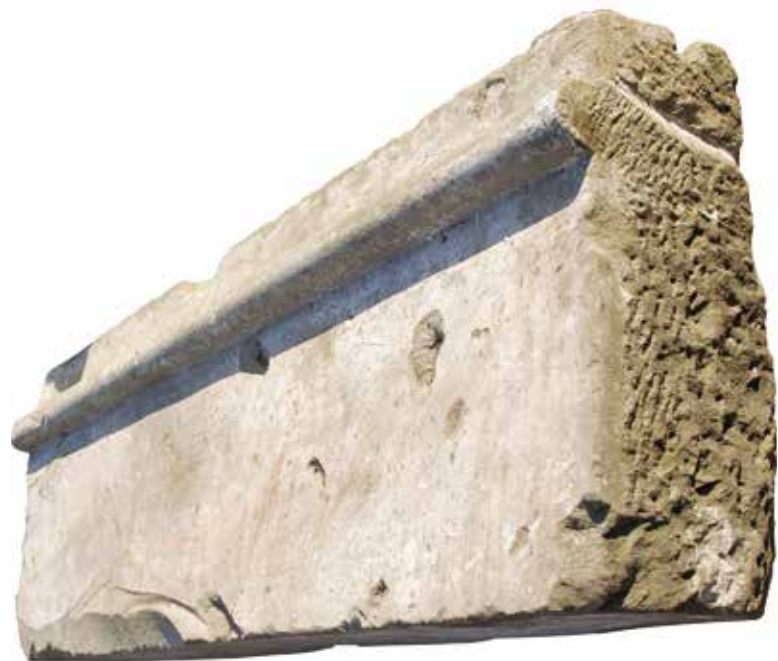
Fig. 5. Outer lintel of the front doorway of the baths (© P. Piraud, Fournet 2012).

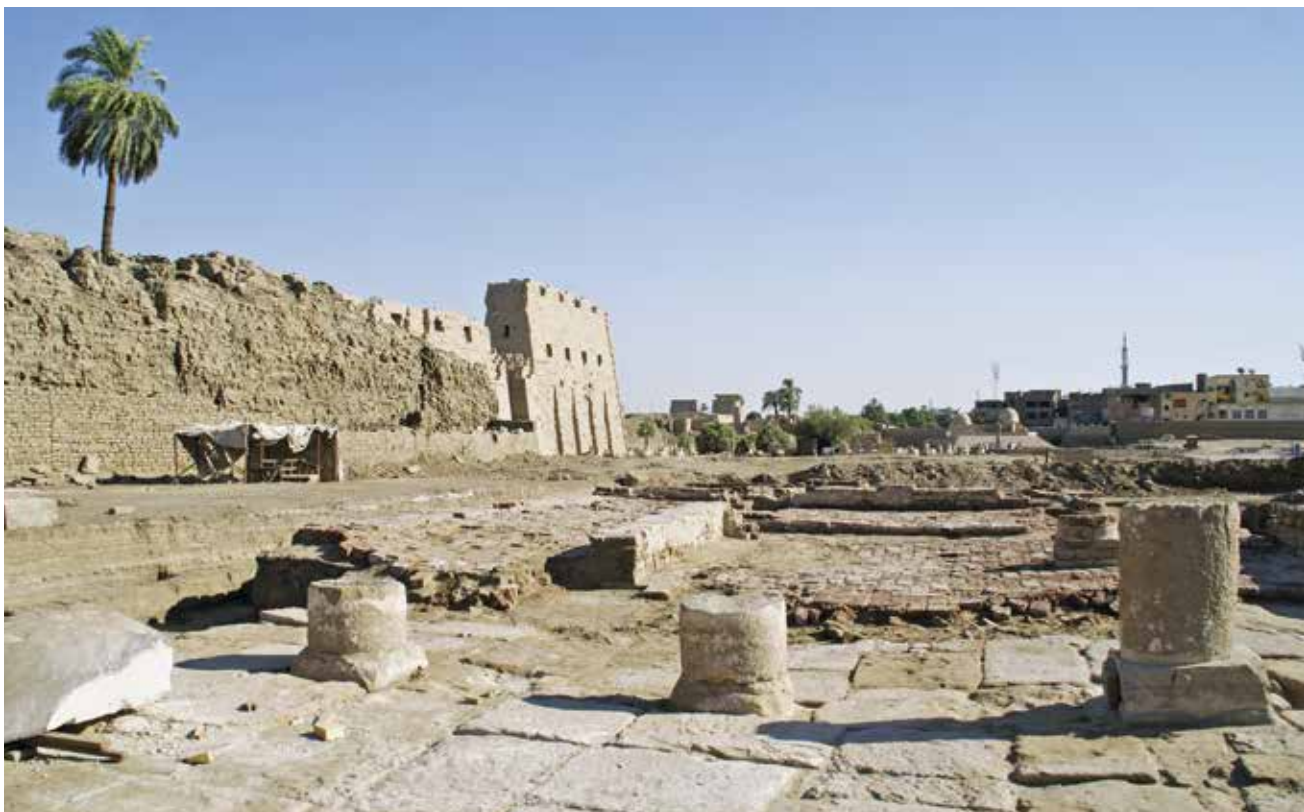
Fig. 7. View, southward, of the columns of Room 1 (© P. Piraud-Fournet 2012).

The six columns of the peristyle are now preserved only to the height of one drum. They were baseless and without moulding, placed on a square die with bevelled corners in their upper part (fig. 7). Five of them were found *in situ* when discovered, the sixth was placed back onto its die. The height of the preserved drums varies between 0.38 and 0.54 m and their diameter of 0.55 m is uniform. Many still have on their top faces the mouth and the cavity where the mortar was poured to affix the upper drum. Two capitals belonging to the baths were found (figs. 8–9). One was lying at the foot of the columns on the stone floor, the other, identical, was re-used in modern buildings that reoccupied the site.<sup>9</sup> In fact, they are only the upper parts of two, extremely pared-down Corinthian capitals, of the so-called Nabataean style (see below on the architectural elements). Their shape fits a square of 0.88 m wide and a rectangle of 0.21 m tall. They have no pattern or decoration, with four prominent and smooth corner horns, and a very prominent axial rectangular button on all four sides. The six drums and two capitals found on the site were covered with a white painted plaster with traces of red and yellow colour.

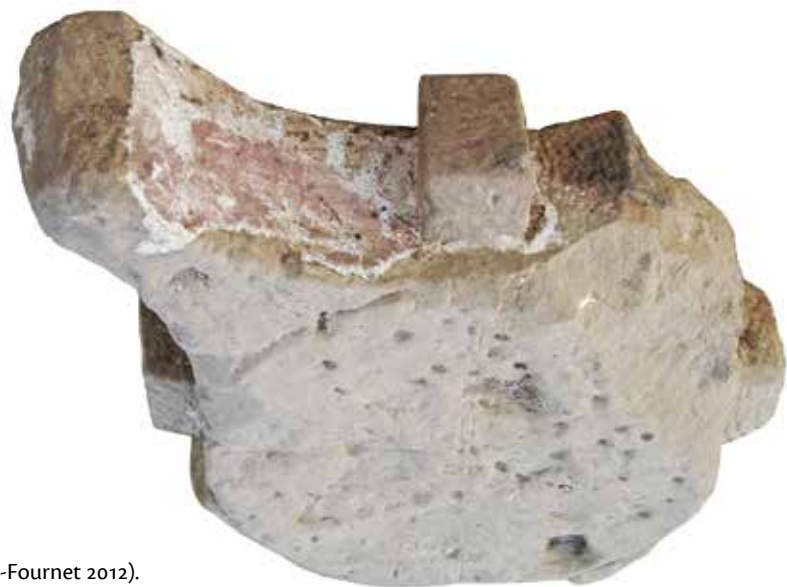
**Fig. 9.** A capital (P. Piraud-Fournet 2012).

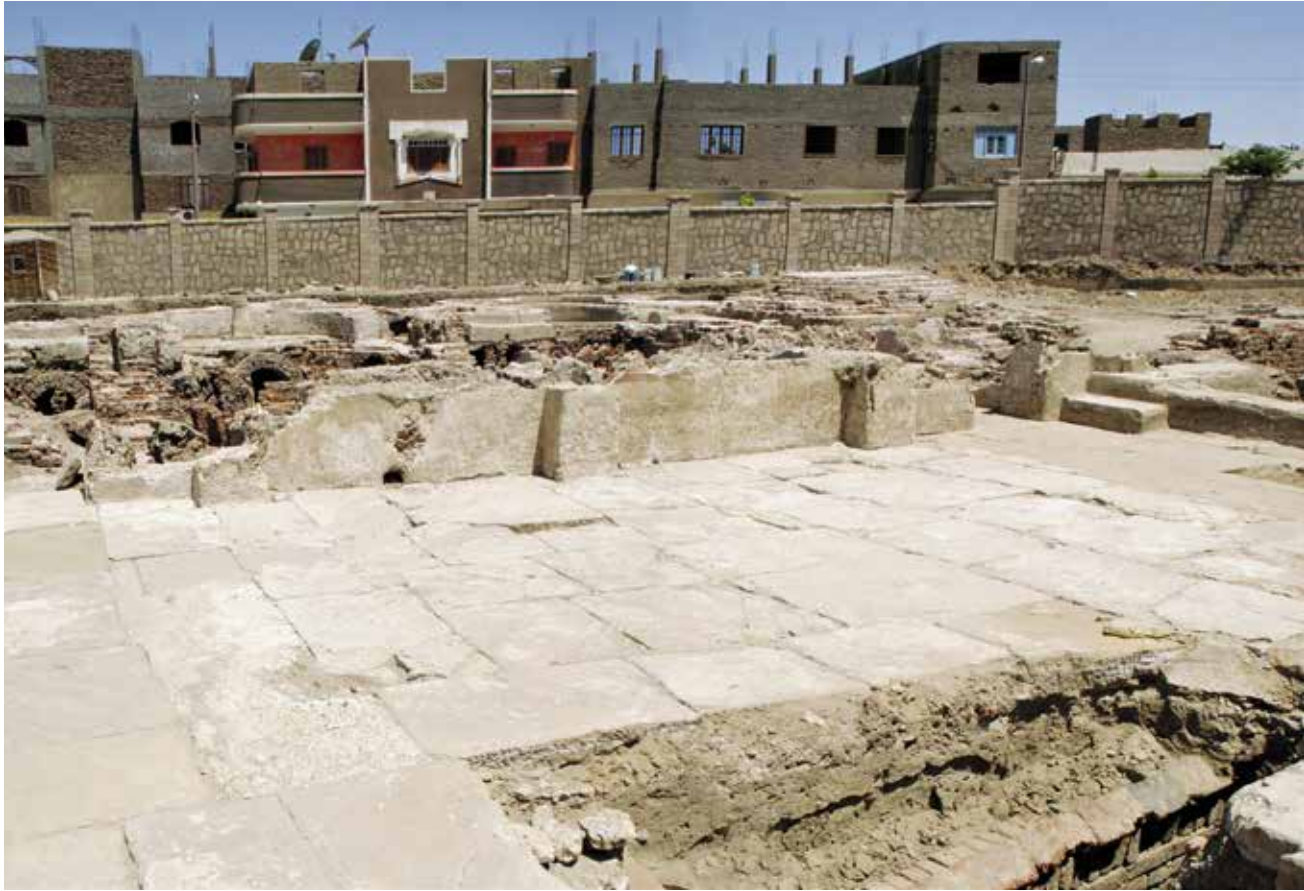
**Fig. 10.** View, westward, of the eastern facade of the thermal section (© Th. Fournet 2012).

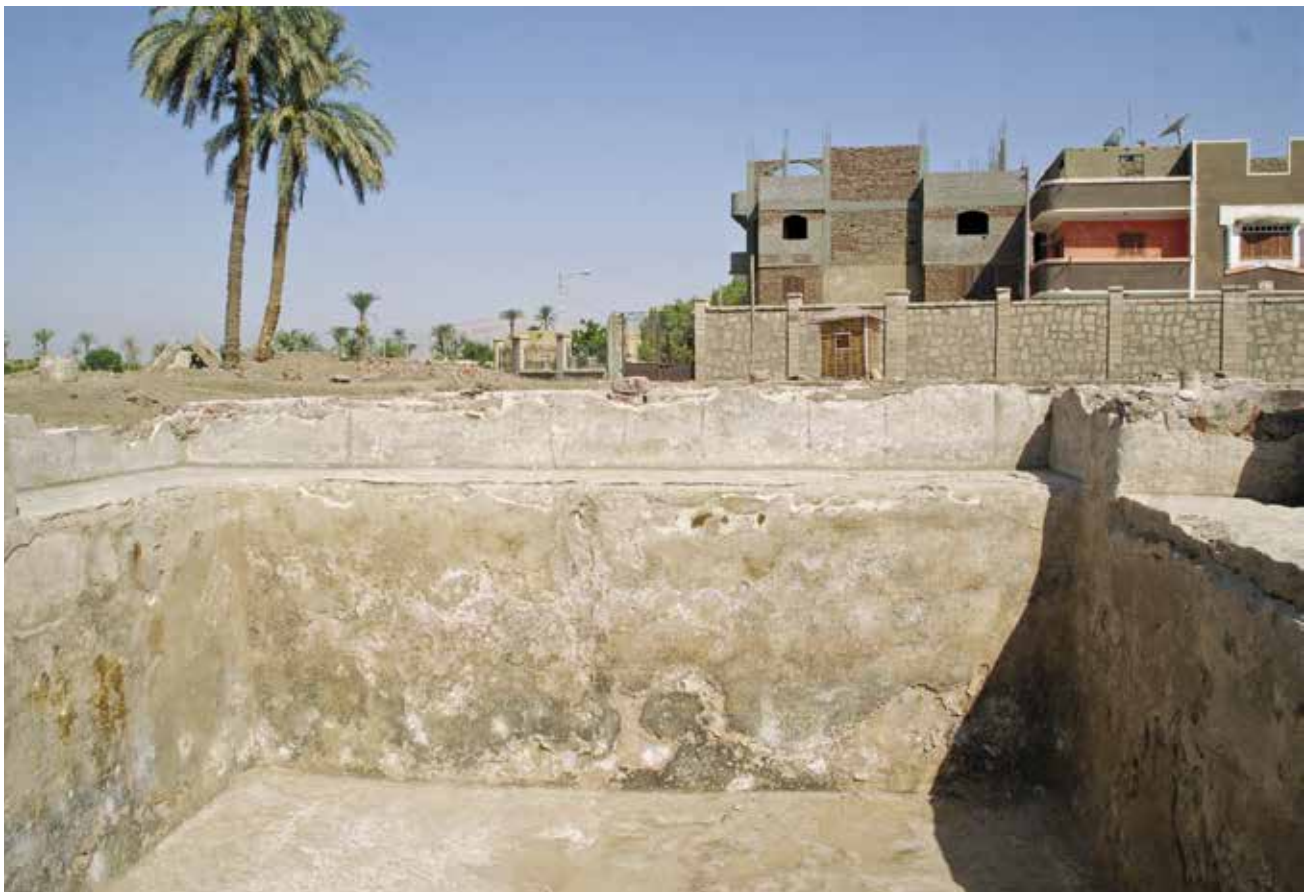
**Fig. 11.** View, westward, of the painted inside wall of Pool 10 (© P. Piraud-Fournet 2012).

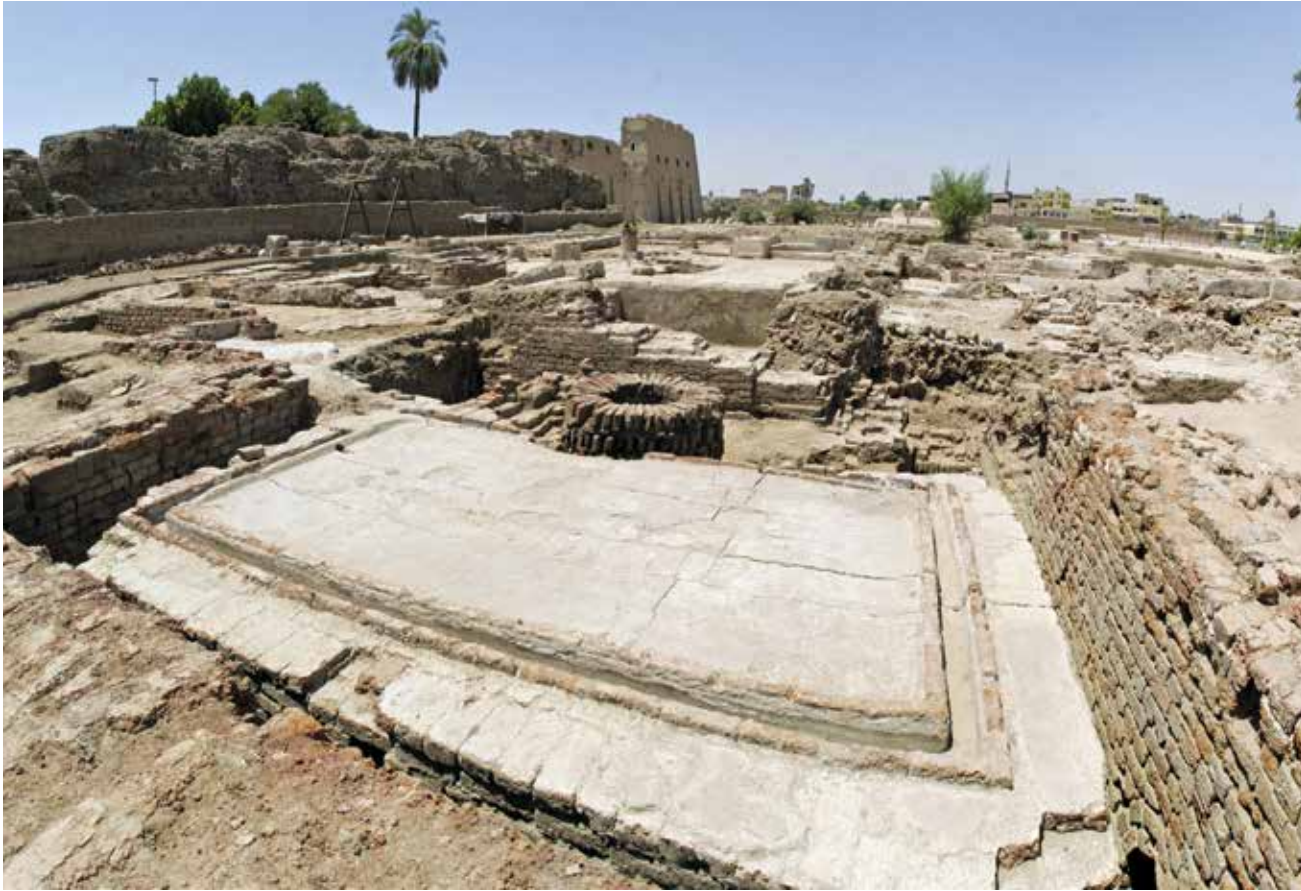
Fig. 12. Panorama of the latrines, southward (© Th. Fournet 2012).

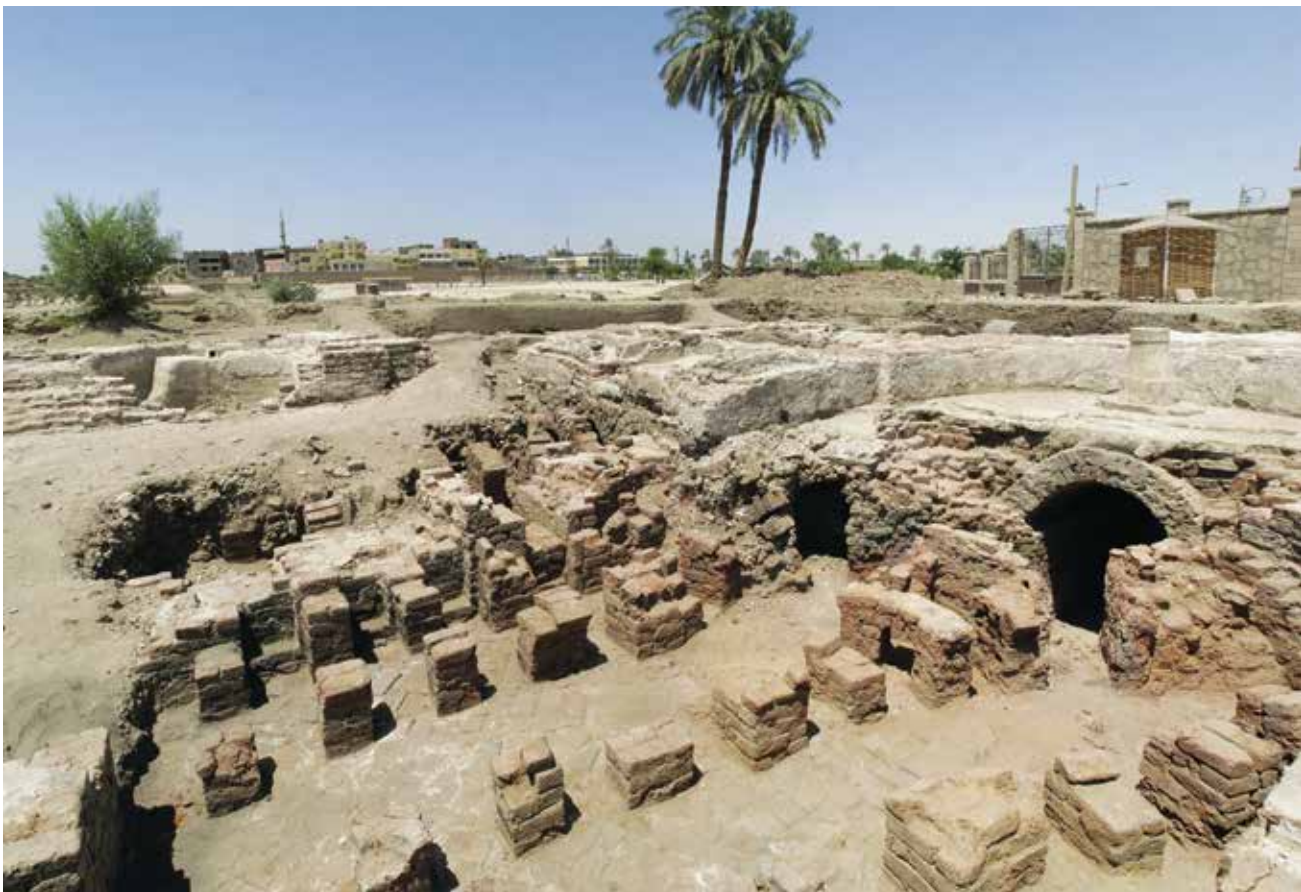
Fig. 13. View, westward, of the heated rooms and their hypocausts (© Th. Fournet 2012).

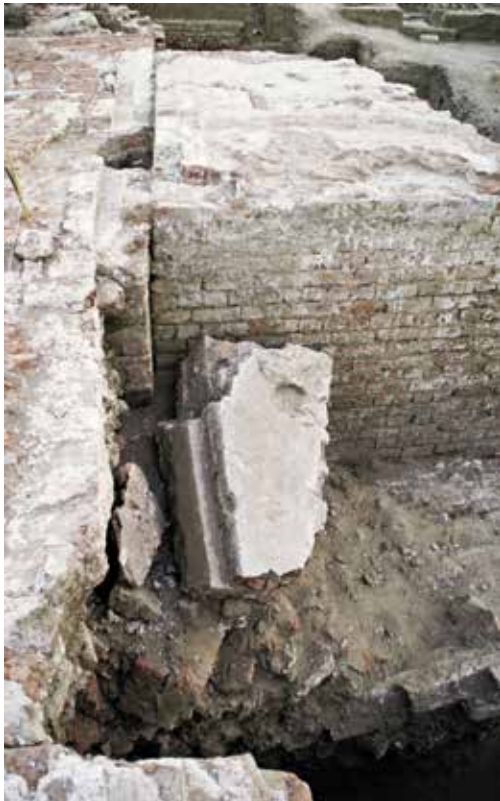
**Fig. 14.** View, southward, of the western aqueduct (© P. Piraud-Fournet 2012).

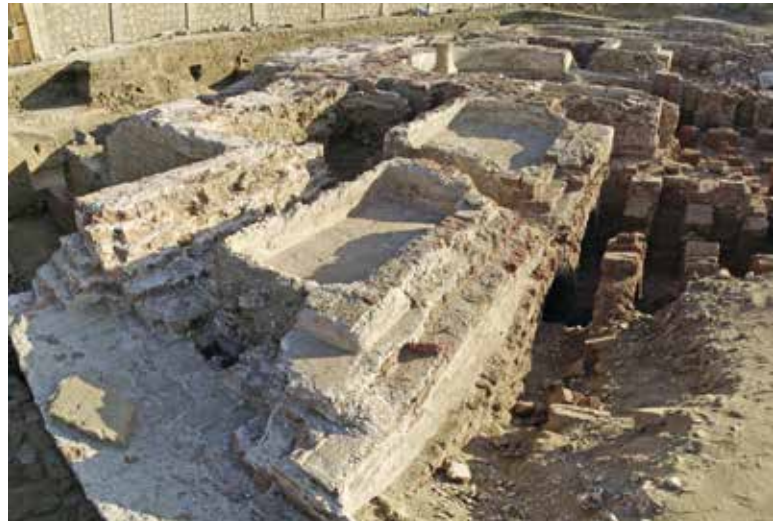
**Fig. 16.** View, northward, of Basins 22 and 23 (© Th. Fournet 2012).

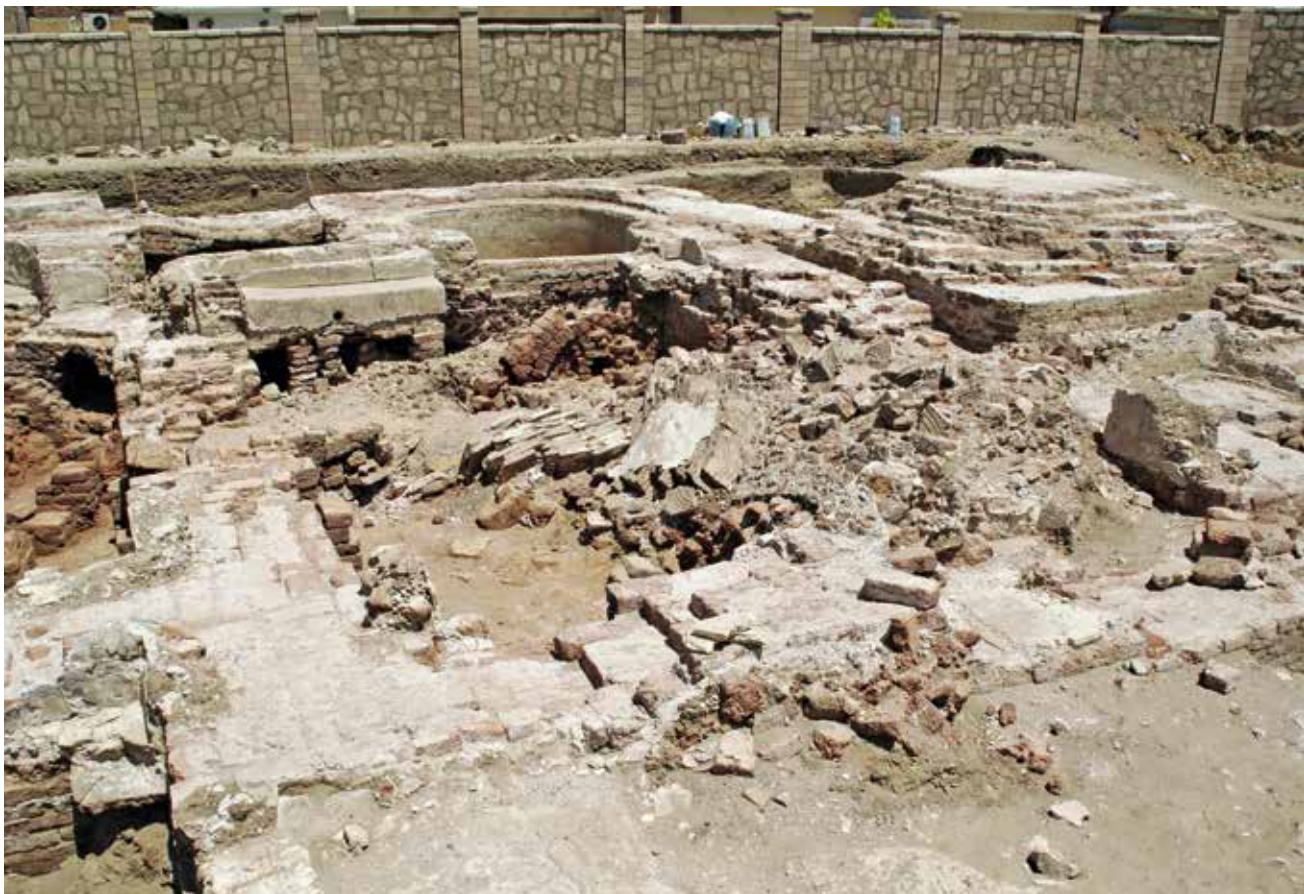
**Fig. 15.** View, north-westward, of the ruined vault of Room 32 (© Th. Fournet 2012).

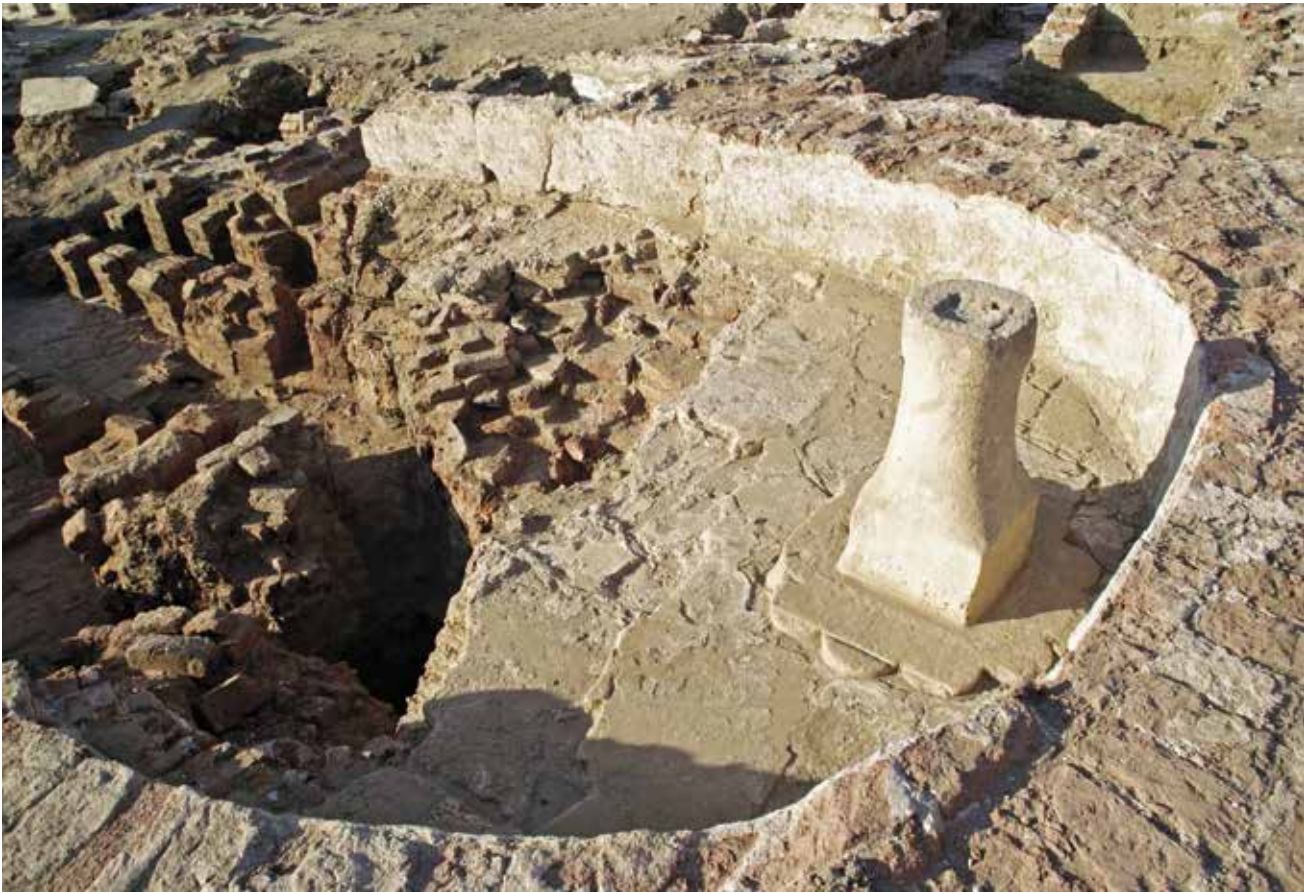
Fig. 17. View, south-eastward, of Apse 5 and the base of the *labrum* (© P. Piraud-Fournet 2012).

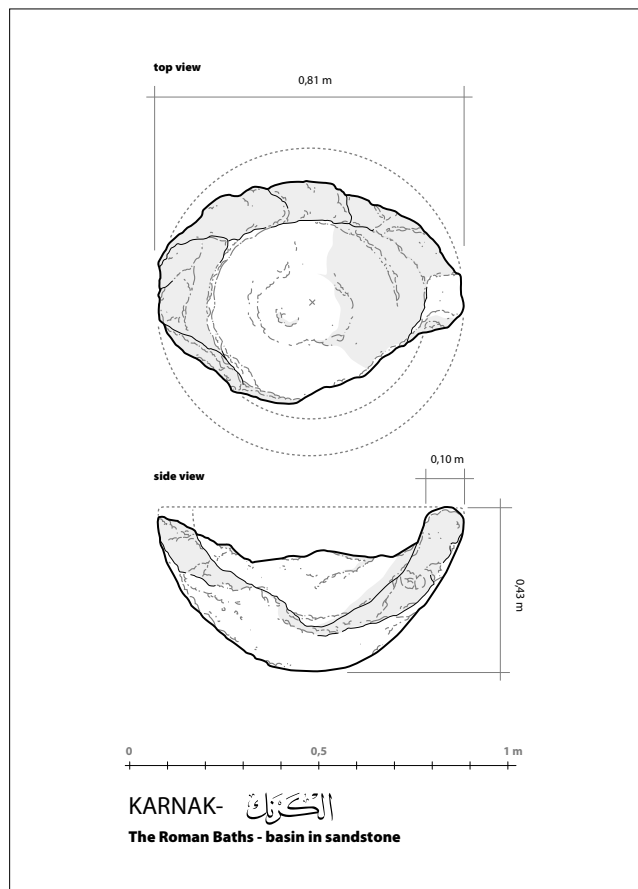
Fig. 19. Drawing of a basin (© P. Piraud-Fournet 2012).

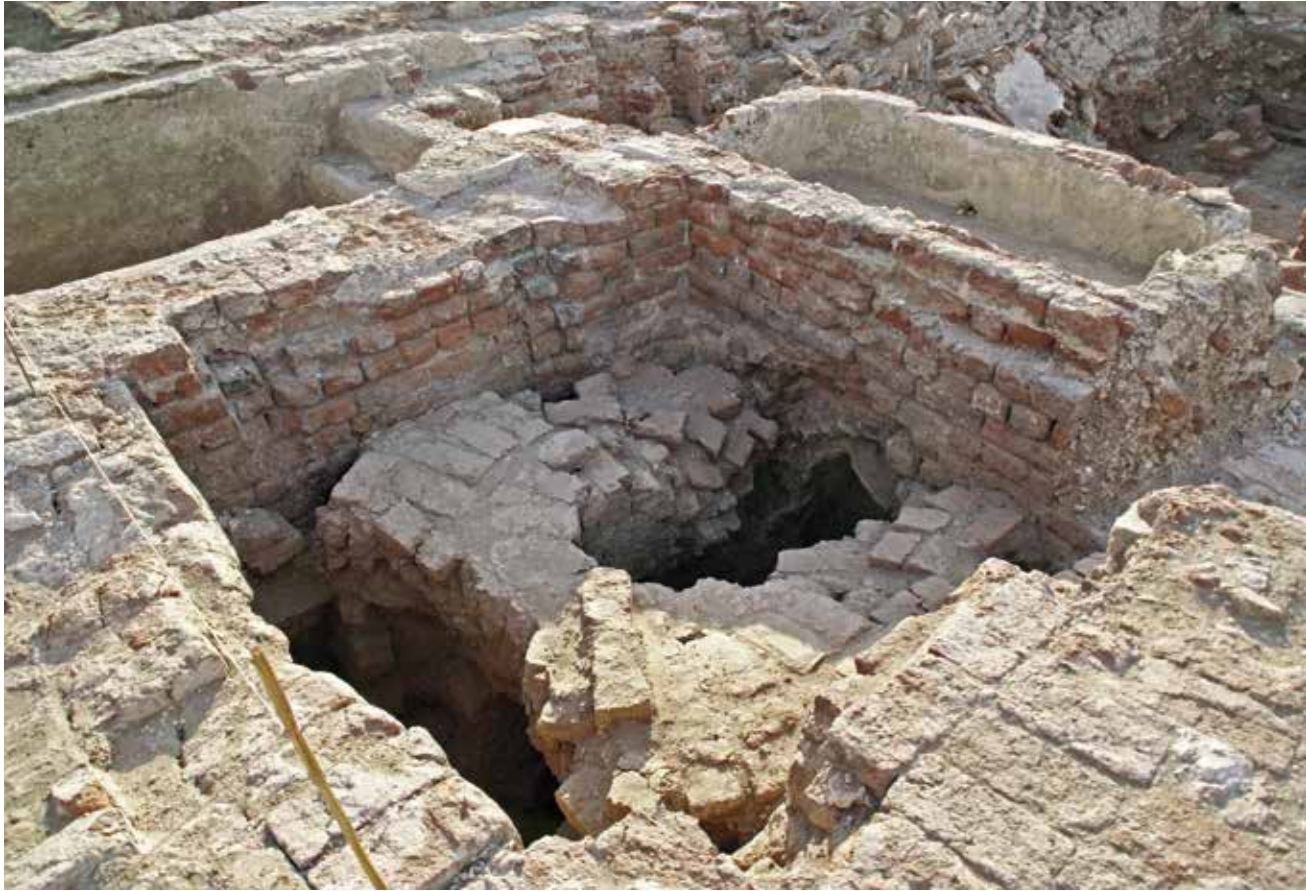
**Fig. 20.** View, north-eastward, of the structures containing Boiler 33 (© Th. Fournet 2012).

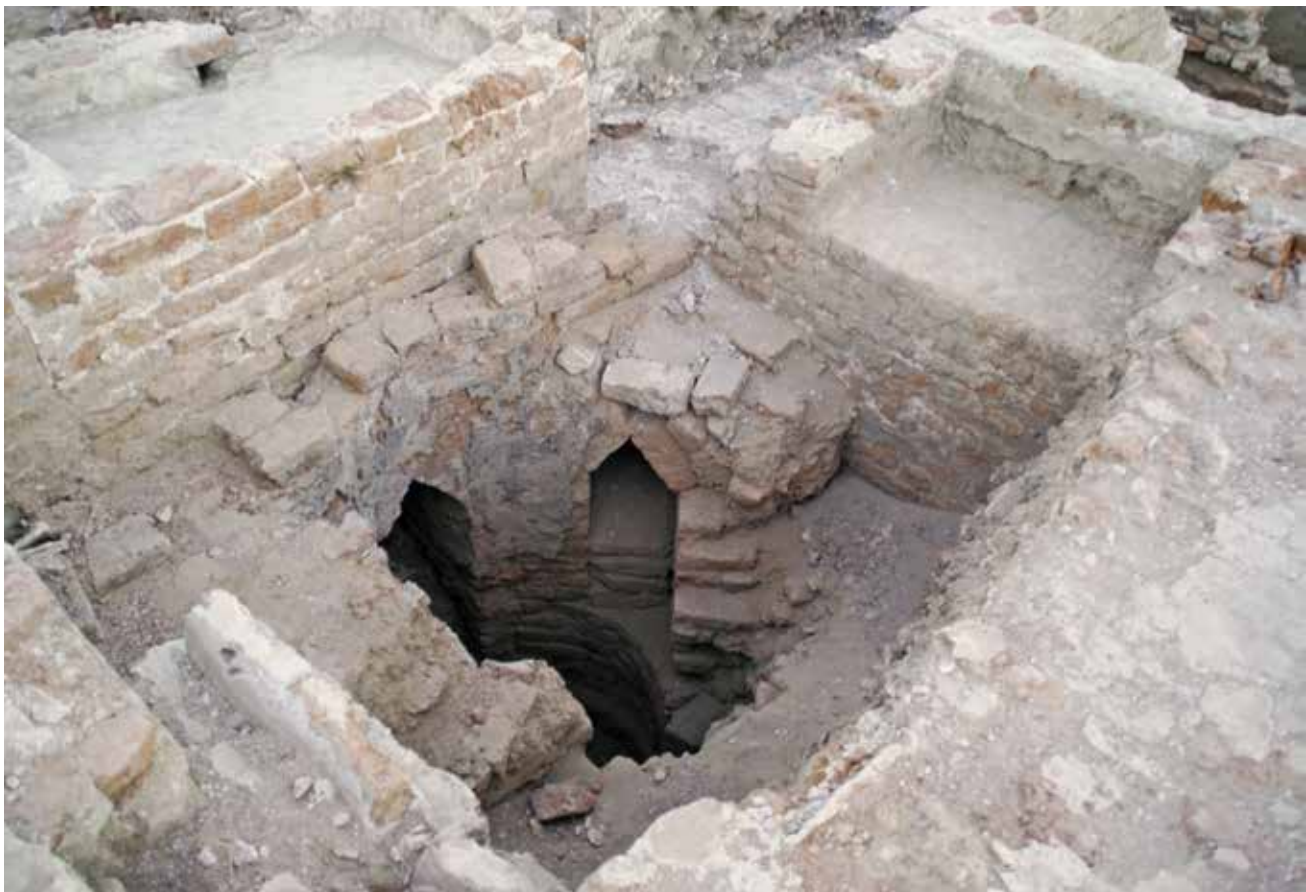
**Fig. 21.** View, south-eastward, of structures containing Boiler 13 (© P. Piraud-Fournet 2012).

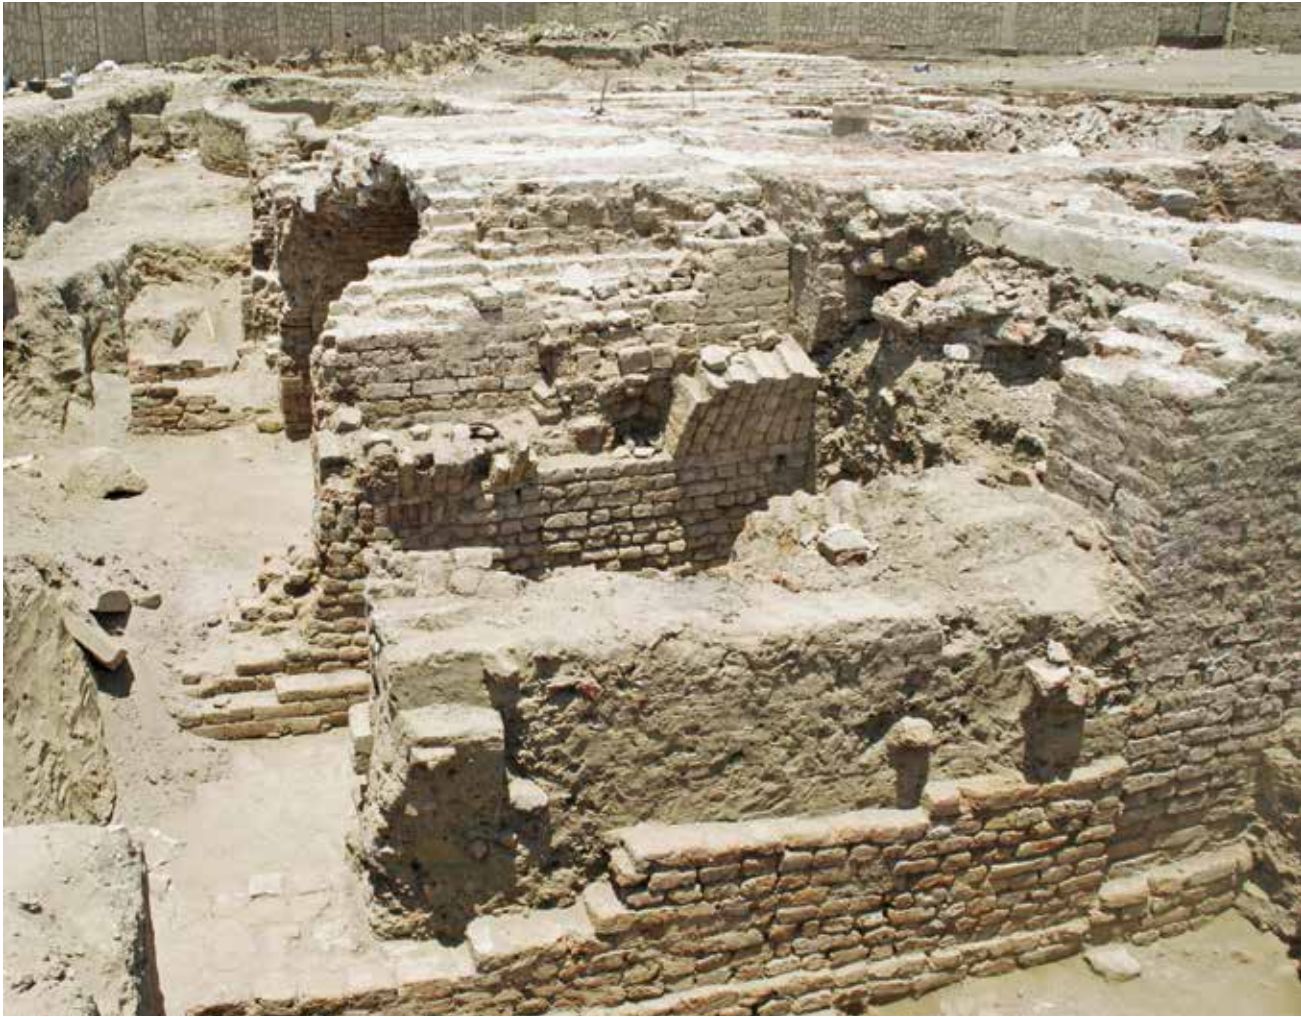
Fig. 22. View, north-eastward, of service rooms (© P. Piraud-Fournet 2012).

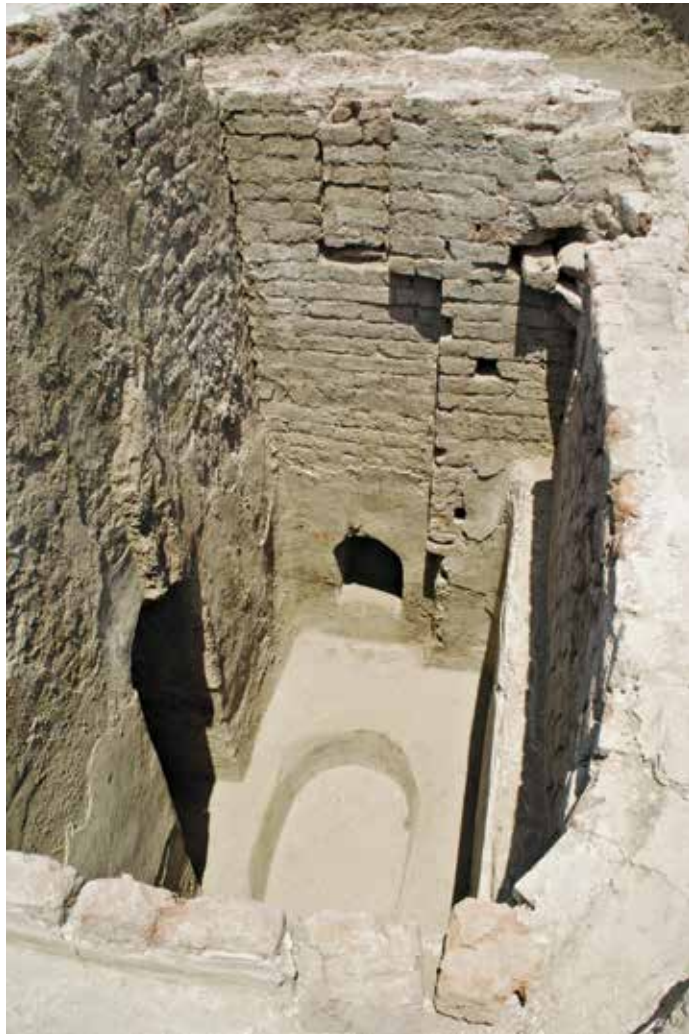
Fig. 23. View looking west of Tank 42 (© Th. Fournet 2012).

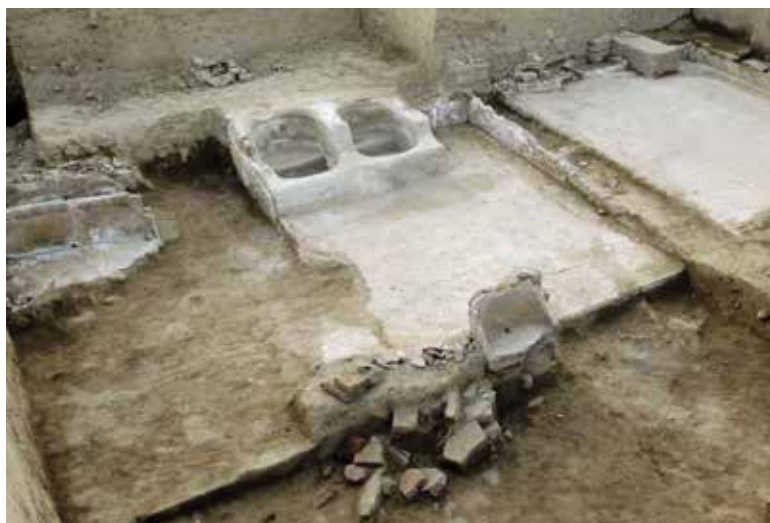
Fig. 24. View of the Ptolemaic bathtubs (Room 49) at the end of the excavations (© SCA, S. el-Masekh 2013), looking east.

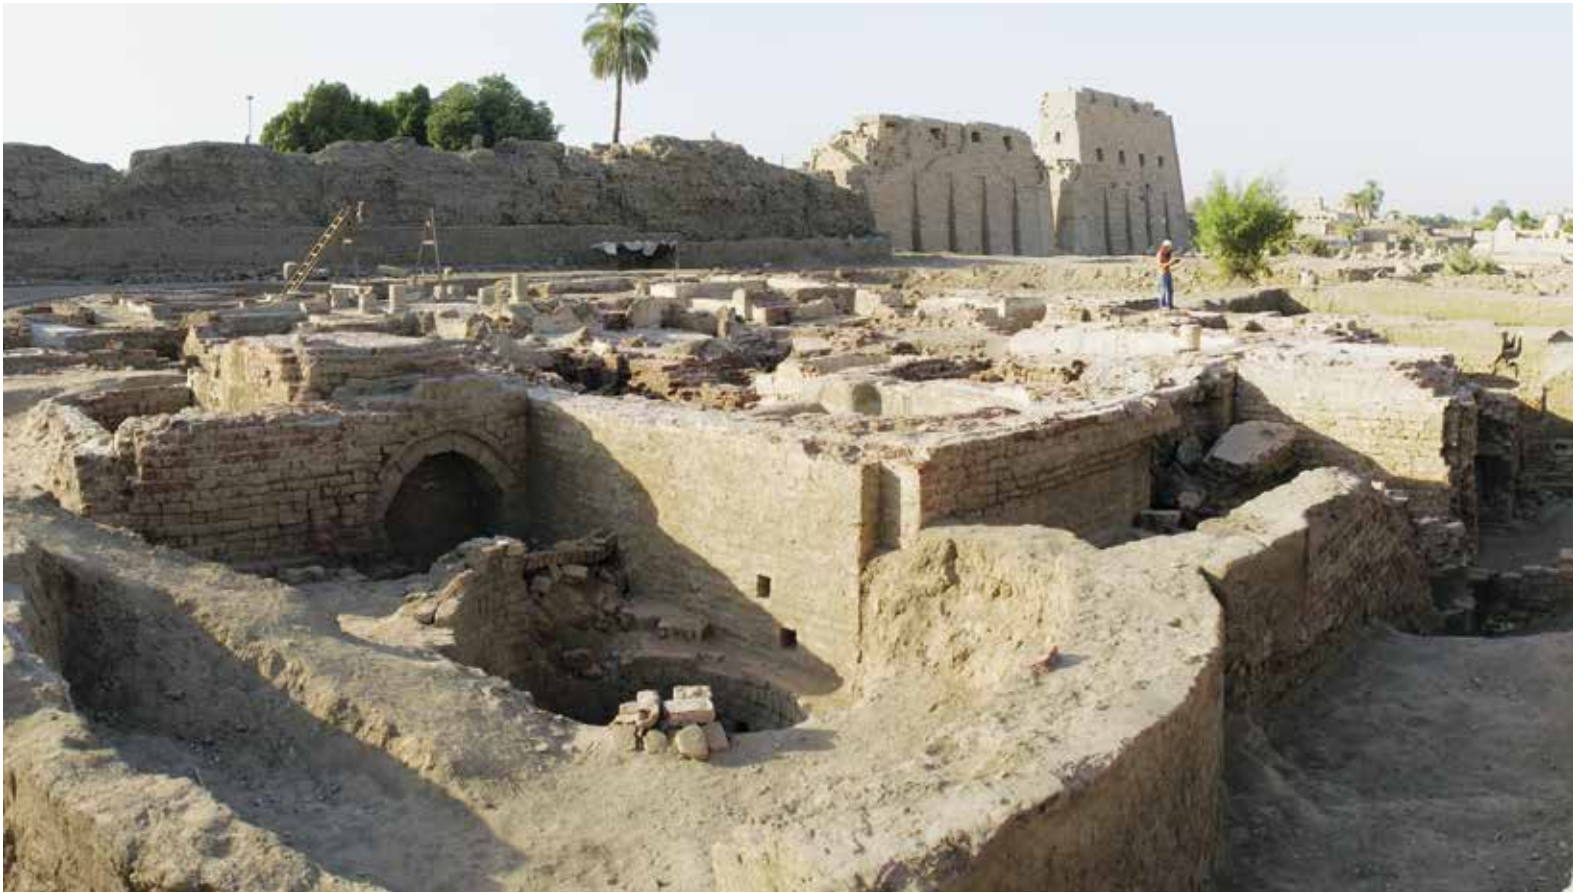
Fig. 27. Panoramic view, southward, of the remains of the Karnak baths (© Th. Fournet 2014).

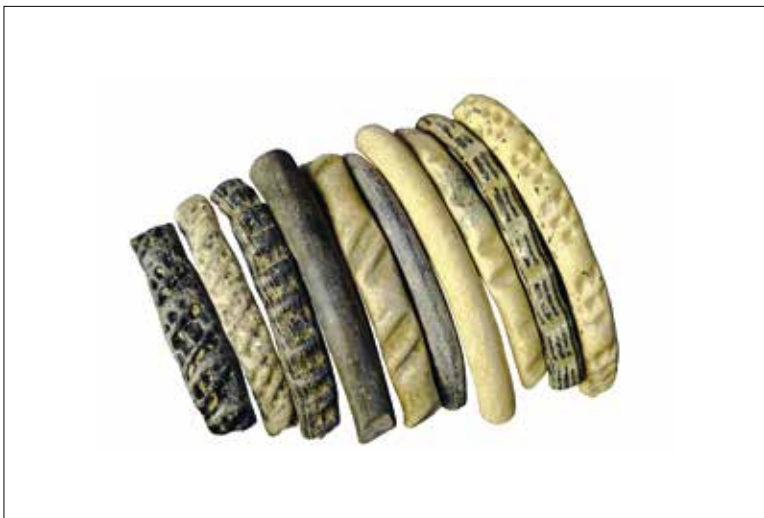
Fig. 29. View of the bracelets found in a pipe of the baths (© SCA 2012).

Several black glass bracelets were found in one of the pipes of the baths (fig. 29). According to Marie-Dominique Nenna, who has only seen pictures of these objects, they belong to an identifiable group of pinch decorated bracelets that dates back to the second half of the 4th century and the 5th century AD.<sup>35</sup>
